The Jacksonville 'Blue China' Shipwreck (Site BA02): A Mid-19th Century American Coastal Schooner off Florida

Ellen Gerth, Neil Cunningham Dobson

Odyssey Marine Exploration, Tampa, USA

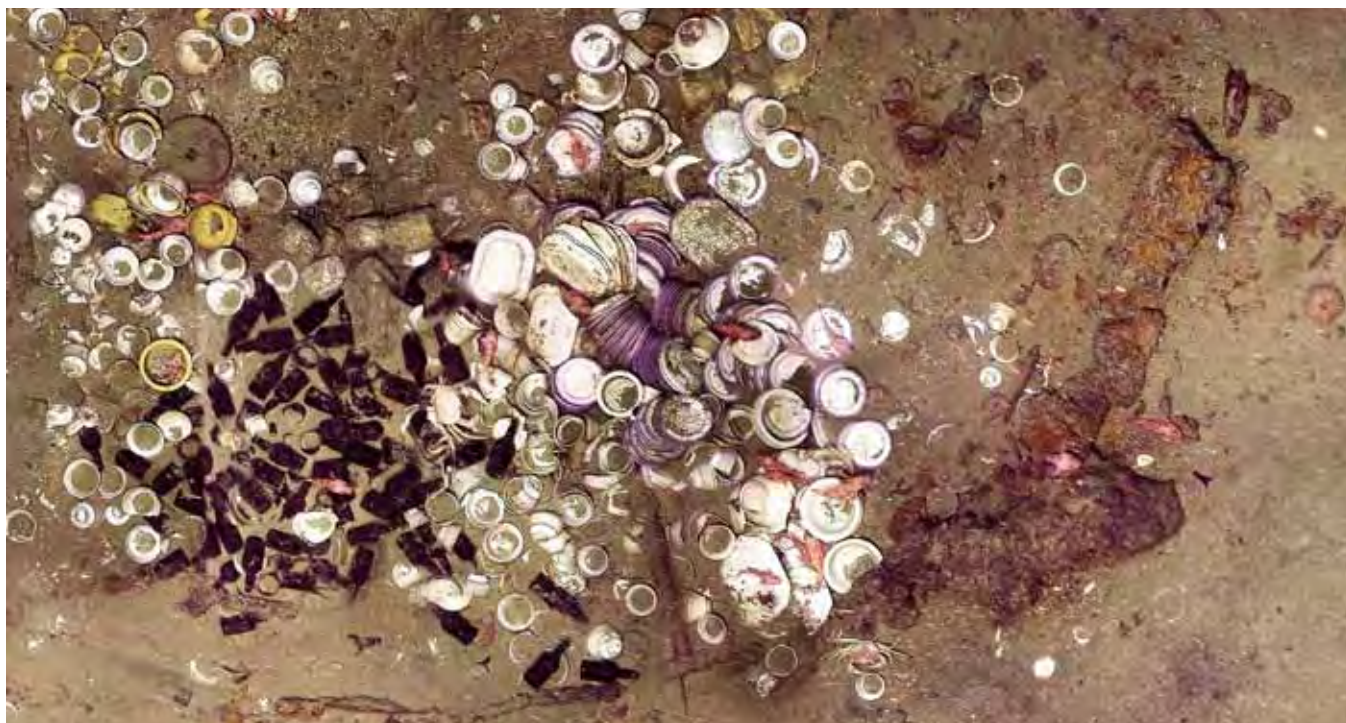
Fig. 6. Photomosaic detail of Area A: shell-edged earthenware plates, soup plates and platters to the south, mixed with dipped whiteware bowls, and a cluster of dark glass bottles to the north. Note the structural remains at east (foreground) and far south (far right, possible stem assembly with hatch rollers to its left), and wooden kegs to the east, which helped preserve this part of the wreck from trawler damage.

The most extensive concentration of cargo is situated towards the bow end of the site in Area A in a dense cluster of pottery and glass wares covering an area of 4.1 x 1.9m (Figs. 5-6, 13-14). The repertoire of the stowed ceramic wares is clearly limited. In the southern half of Area A within a concise zone measuring 1.9 x 1.9m were at least 231 ceramic vessels, restricted in form to 109 shell-edged Type 1A and Type 1B whiteware plates and soup plates (40 within a single stack), 16 Type 1C octagonal shell-edged whiteware platters and 105 Type 2A dipped whiteware bowls (Figs. 15, 17-22, 47-48). A single Type 2B dipped jug lies outside the hull to the west. This is the only section of the wreck where shell-edged wares occur (Fig. 47). Seven Type 4C white granite/white ironstone china wash basins, five still stacked in two sets of three and two, are also present to the south of Area A (Fig. 50). All of these ceramics are of British origin (see Section 7 below).

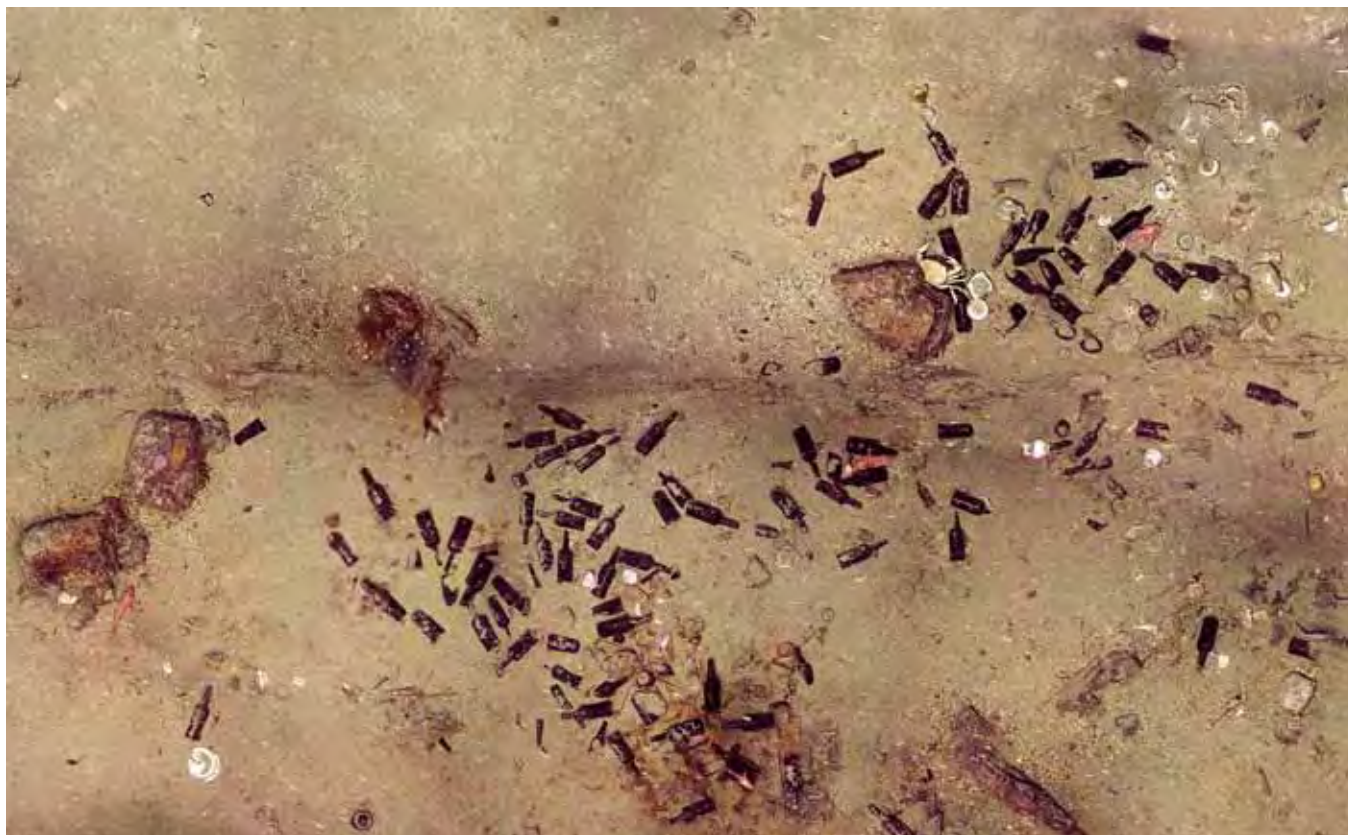
Fig. 7. Photomosaic detail of Area B: a cluster of dark glass bottles, tobacco pipes and large kegs K1-K4 with the buried keel visibly running north/south.

A second less extensive concentration of cargo occurs to the north of the stern section of the wreck in Area B, where 115 Type 1 black glass liquor bottles cover an area of 5.7 x 3.9m and straddle both the eastern and western side of the keel (Figs. 5, 7, 24, 25). Although these have been scattered by trawlers and are far more loosely clustered, this deposit gives the impression of having been stowed midship in the stern. Area B is bounded on the north and east by four

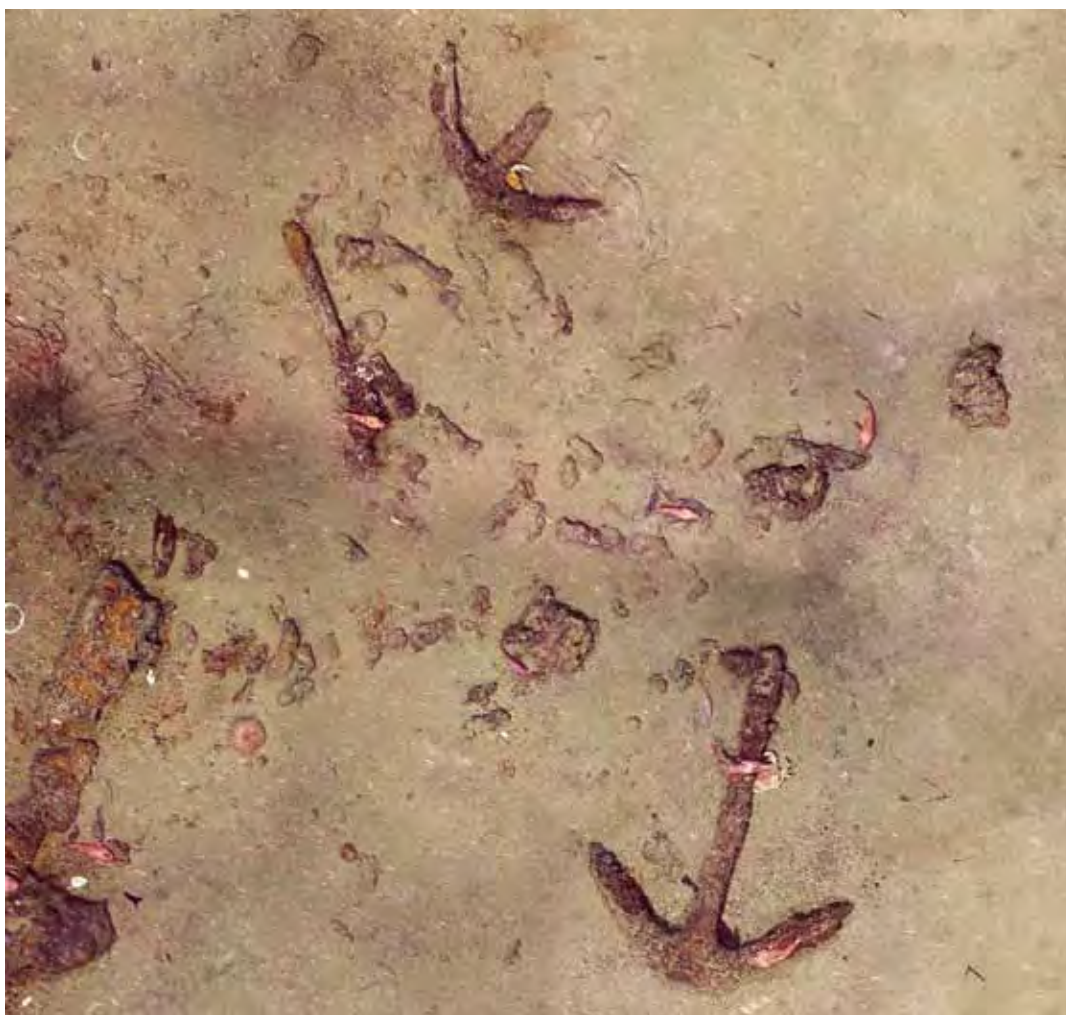
Fig. 8. Photomosaic detail of Area C: two iron anchors at the bows with the possible stem assembly towards the north (far left).

Two concreted iron anchors are associated with Site BA02 and define the southernmost flank of the wreck (Area C). Both were evidently still lashed to the bows when the ship sank (Figs. 4, 5, 8). Anchor A1 is located 2.2m northeast of the end of the visible articulated wreckage (defined by the eastern tip of a large sub-rectangular iron concretion that may be part of the stem assembly). A1 is broken and only a section of the crown, arms and the lower shank are preserved (surviving L. 57.7cm, shank W. 11.6cm; Fig. 28). The arms are gently rounded, 58.7cm long, and measure 1.1m between the fluke tips. A second section of concreted iron lying just 78cm to its southwest, surmounted by a ring, seems to be the missing section of the shank (L. 1.12m, Th. 9.4cm). This suggests a total length for anchor A1 of 1.69m, which is consistent with the dimensions of anchor A2.

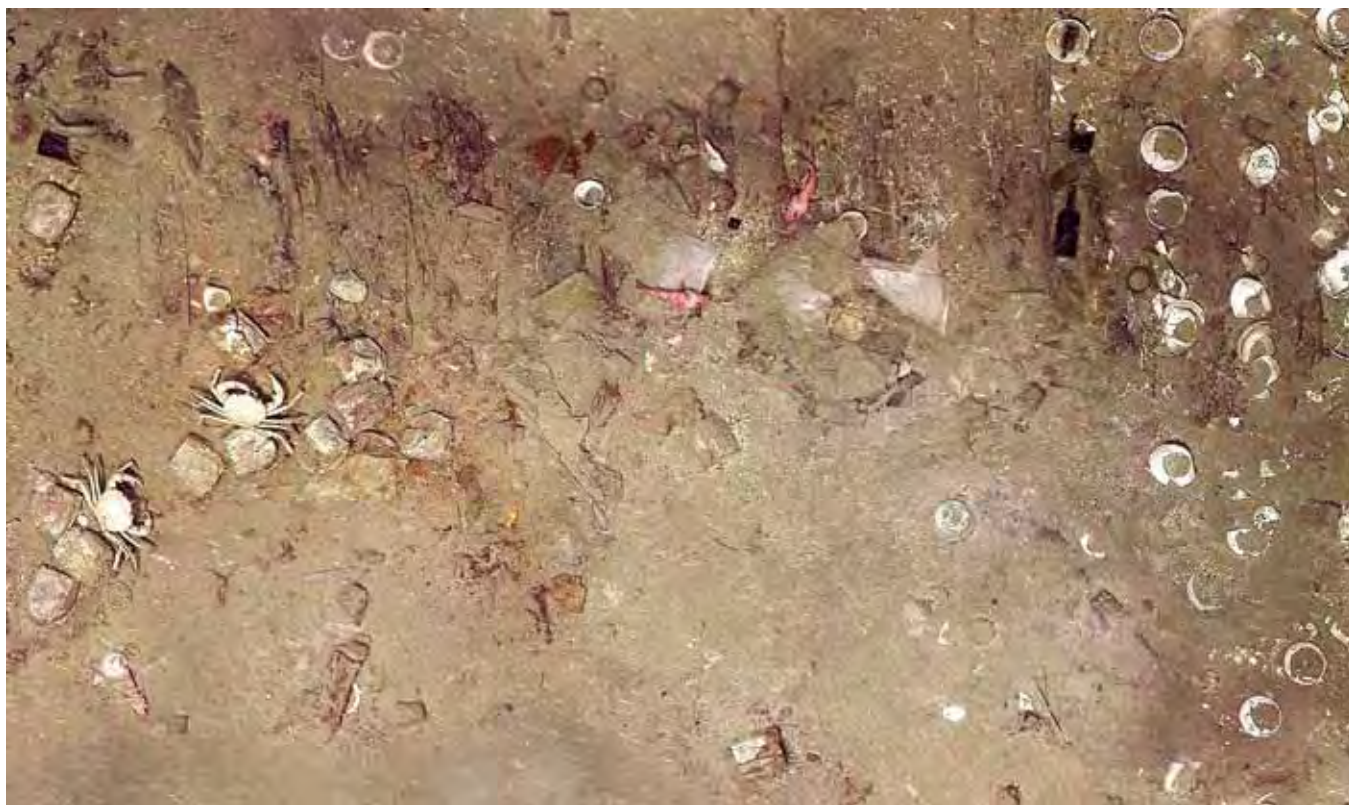
Fig. 9. Photomosaic detail of Area D: glass window panes overlying wooden frames at right and center, with wooden kegs to the north (at left).

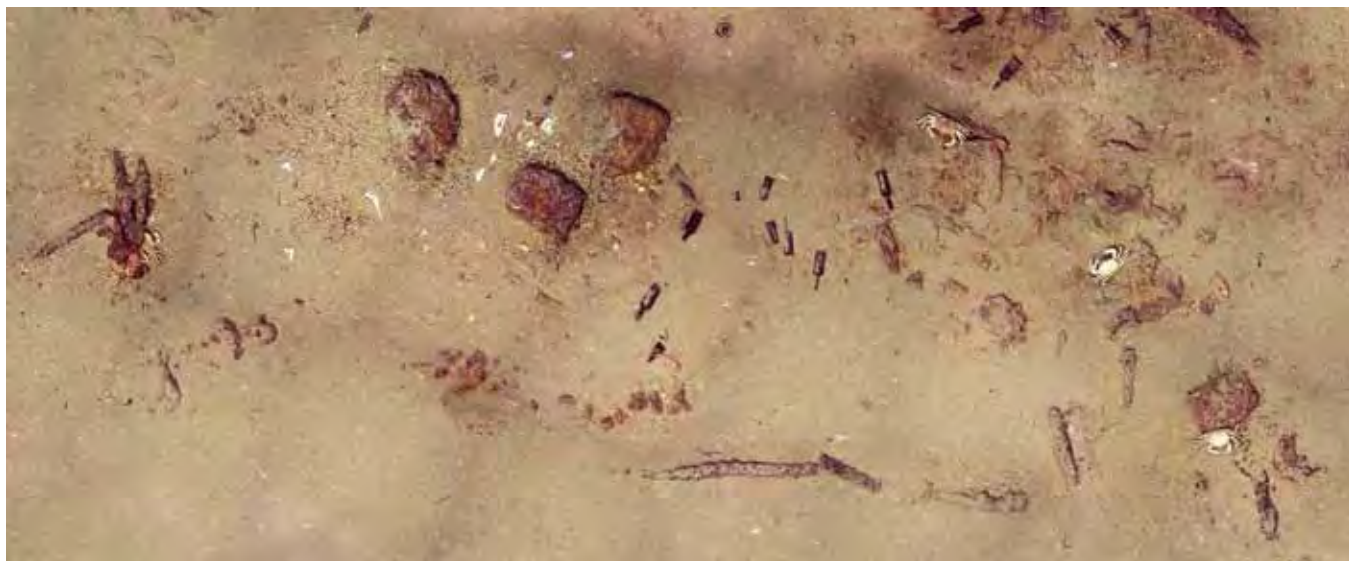
Fig. 10. Photomosaic detail of Area E in the stern: a concreted tripod (E1, far left), large kegs K5-K7, and at far right keg K9 and CN1, a concreted feature, possibly a rudder gudgeon.

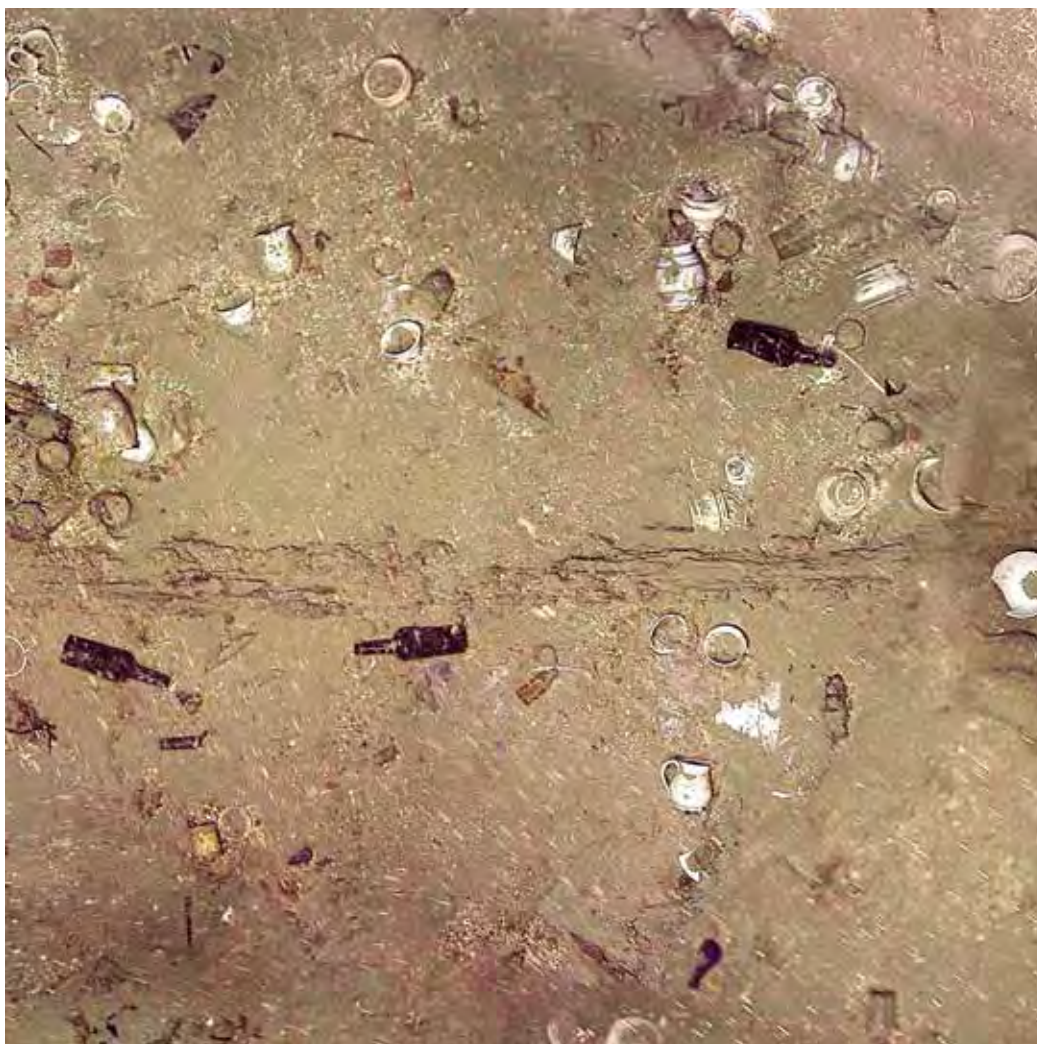
Fig. 11. Photomosaic detail of Area F: the north/south running keel at center surrounded by underglaze painted whiteware cream jugs, sugar bowls and tea bowls (tea service cargo) and glass window panes in the foreground.

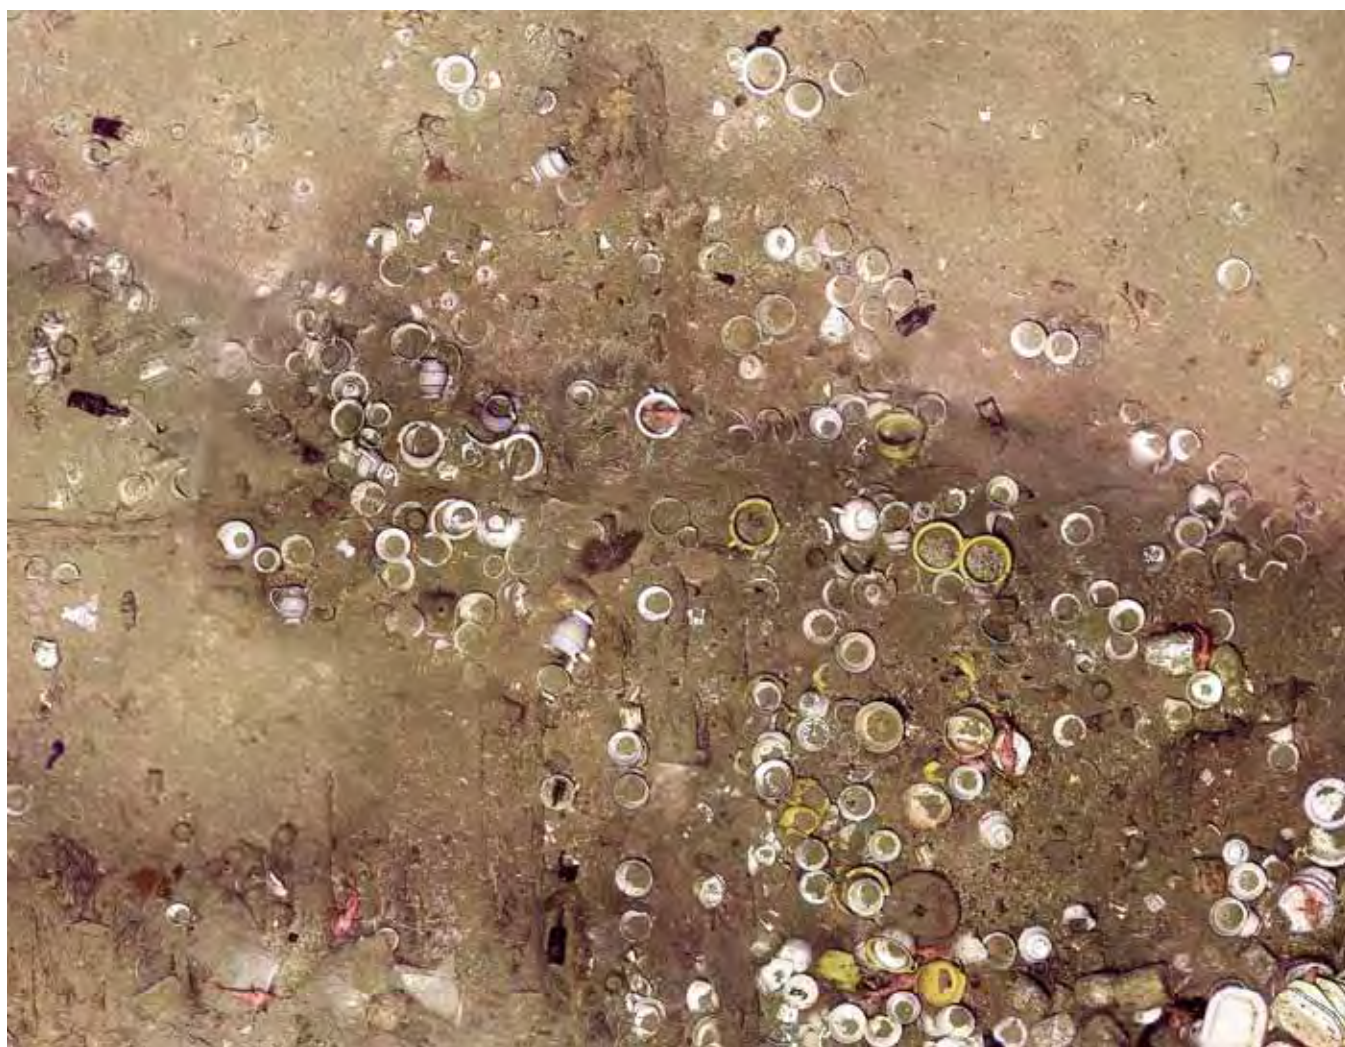
Fig. 12. Photomosaic detail of Area G: scattered white ironstone china, dipped yellow chamber pots, whitewares, and glass tumblers at left. Area A is visible at bottom right and Area D at bottom left.

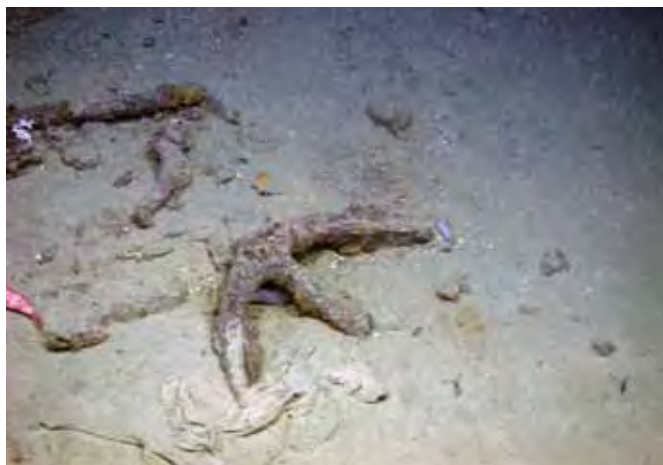
Fig. 28. Anchor A1 in the bows at the southernmost end of Site BA02, with its probable broken shank behind.

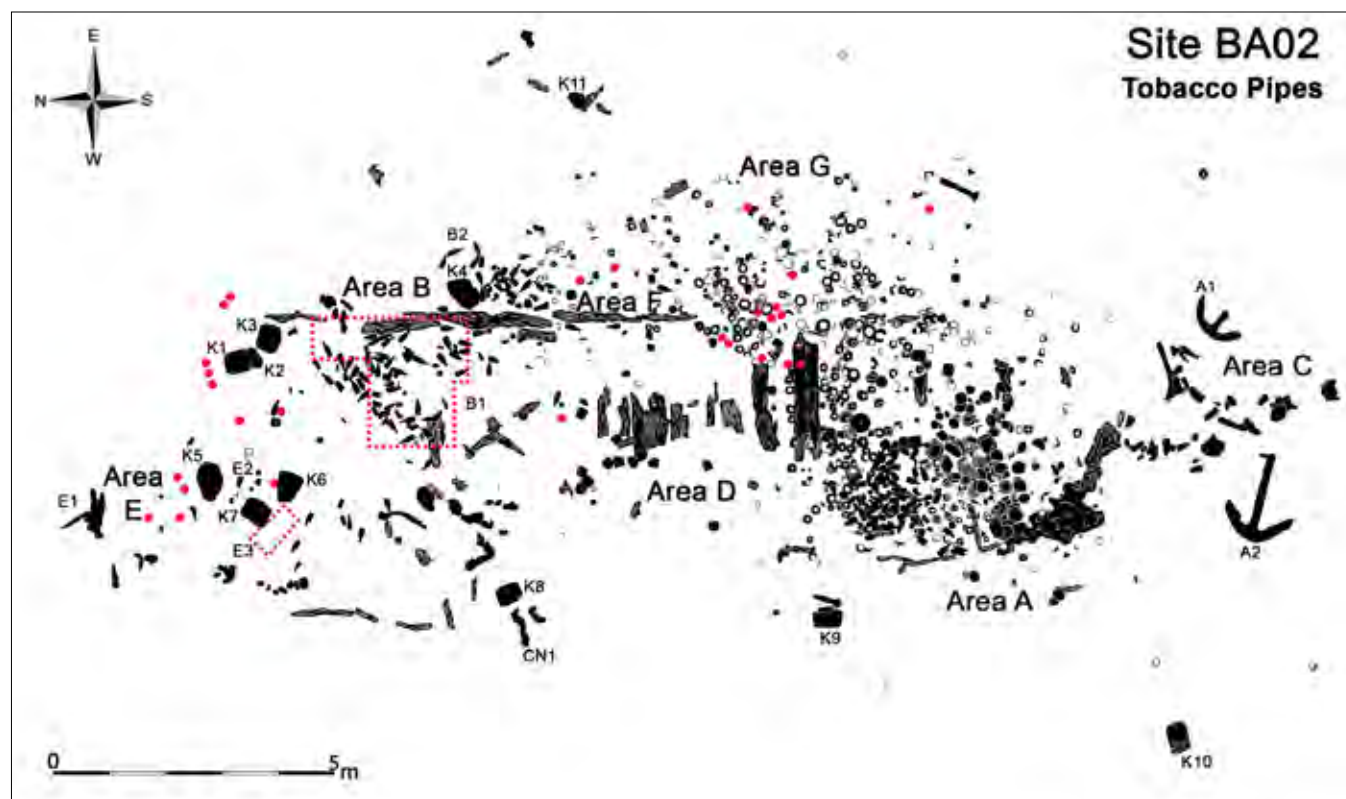
Fig. 52. The distribution of clay tobacco pipes on Site BA02.

The pipe assemblage from Site BA02 is clearly cargo. The material is highly scattered across the wreck in a zone extending from the northernmost flank in Area E, through Areas B, F and G. Two main clusters occur to the north, with Area B containing 39 pipes (33 in Area B1) and 11 pipes in Area E (six in Area E3). A single Type 1 ribbed pipe bowl observed embedded within the concreted top surface of a large keg in Area E (K6) may reflect their source of stowage. A separate subsequent article examines the site's clay smoking pipes in greater detail.

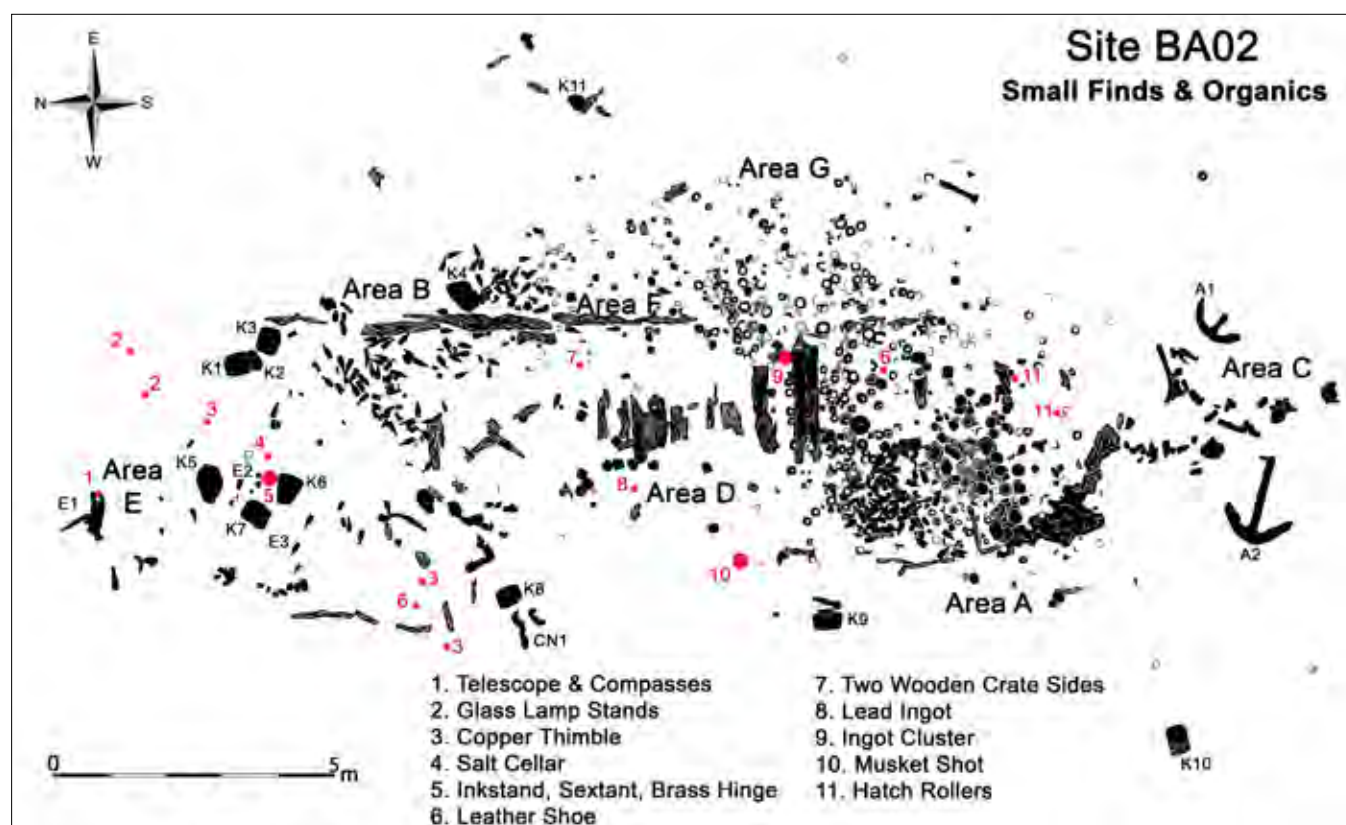
Fig. 55. The distribution of small finds and organic artifacts on Site BA02.

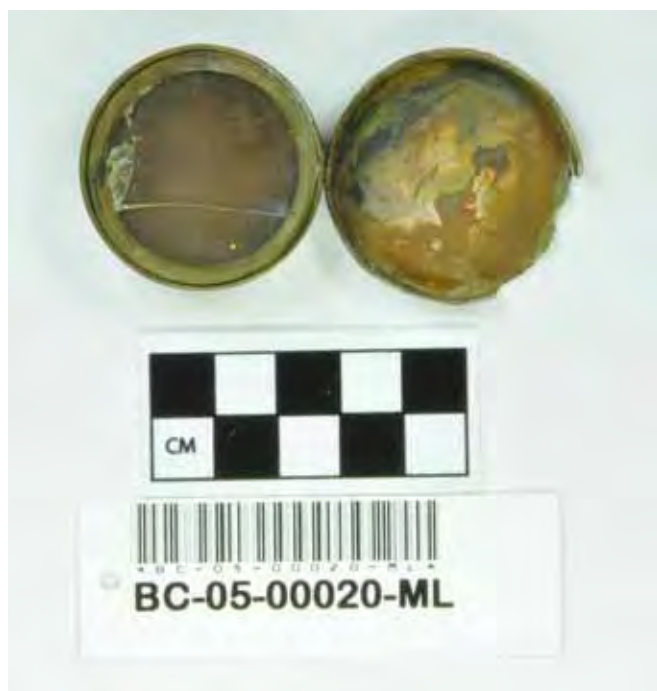
Fig. 76. Cupreous and glass compass BC-05-00020-ML (Diam. 4.0cm). Bar codes are used by the Odyssey conservation lab in accordance with company protocol to track all data relating to an artifact from site name and context to conservation history.

A relatively low volume of metallic and miscellaneous artifacts of different types and compositions was observed and recovered on Site BA02, including ship's fittings, navigation equipment, raw materials and musket shot. The metallic navigational equipment, limited to the northern surface of the site at the stern, included two disc-shaped lidded bronze containers found in Area E1 within the legs of a concreted tripod, presumably used for surveying or astronomy (Fig. 78). One remains sealed, while the opening of the second example during conservation verified that both artifacts are hand-held compasses (Figs. 76-77). BC-05-00020-ML is a circular cupreous housing composed of a flat lid with a screw thread that connects the object to its base, which features a convex underside. Within is a compass with a central glass mount and a north crosshair at center (lid H. 0.55cm, Diam. 4.0cm, Th. 0.12cm; base H. 1.1cm, Diam. 3.6cm, glass compass Diam. 3.05cm, north crosshair Diam. 0.6cm; weight 34gr). BC-05-00208-UN is a sealed compass (total H. 1.5cm, lid Diam. 4.0cm, base Diam. 3.7cm, base

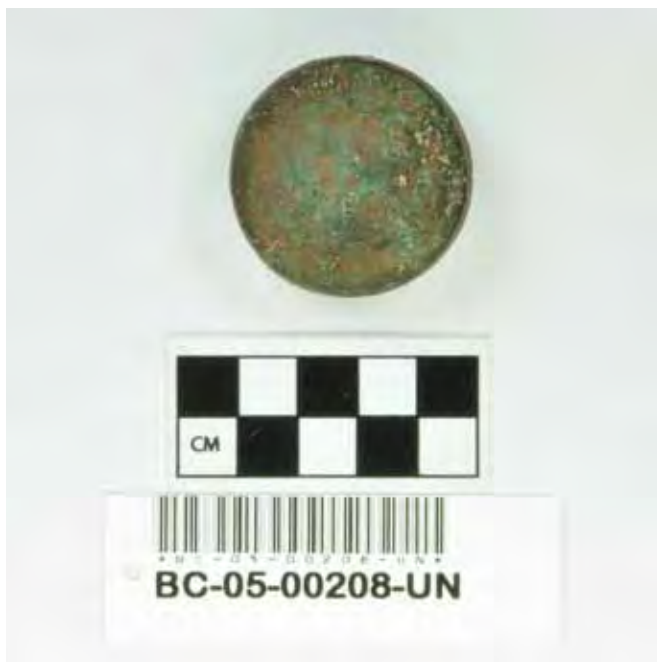
Fig. 77. Cupreous and glass compass BC-05-00208-UN (Diam. 4.0cm).

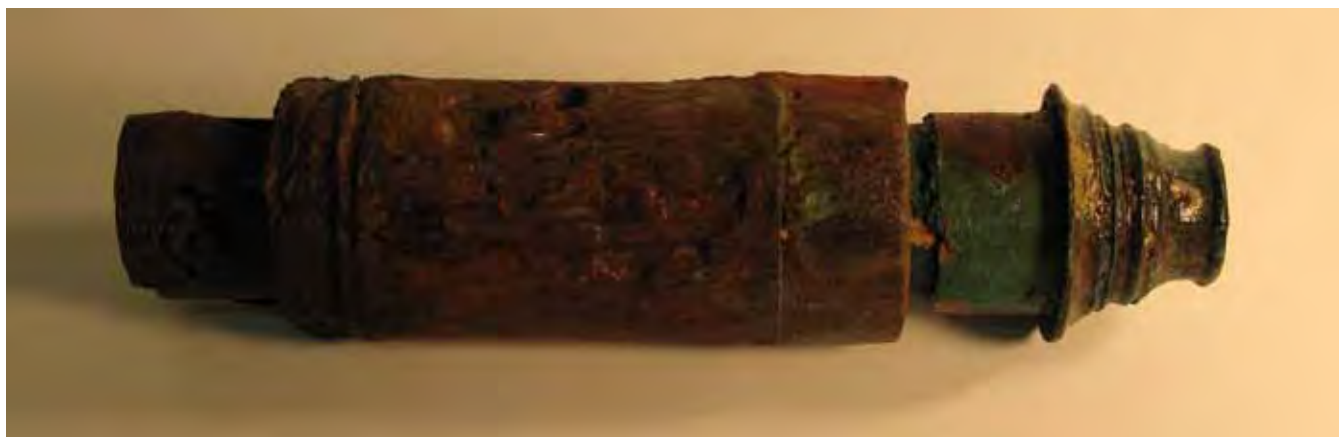
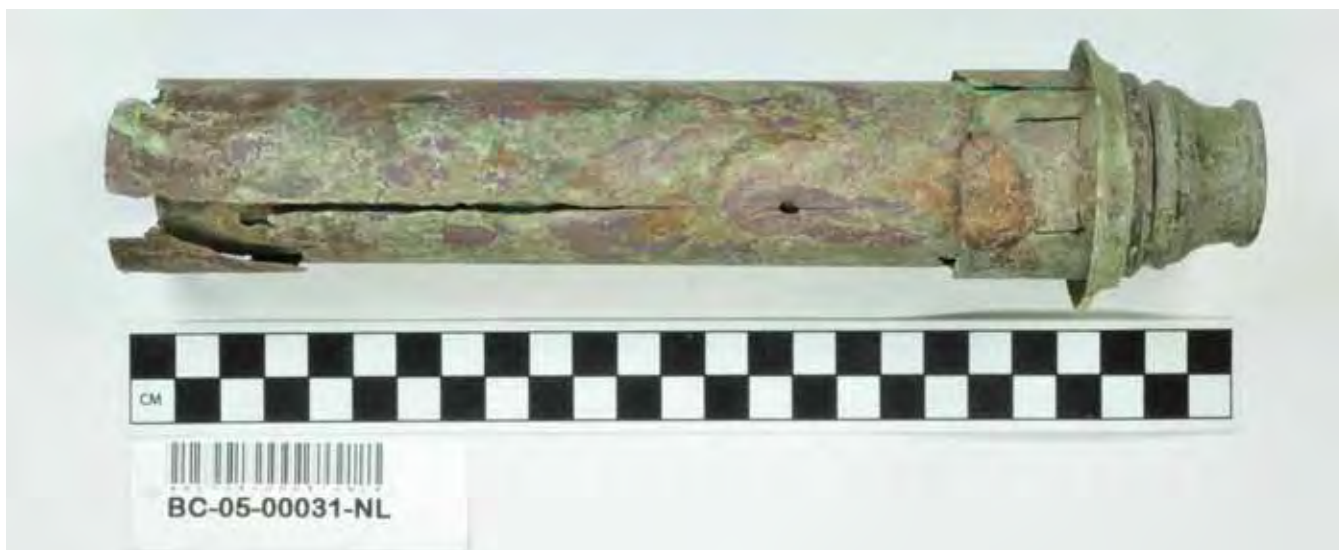
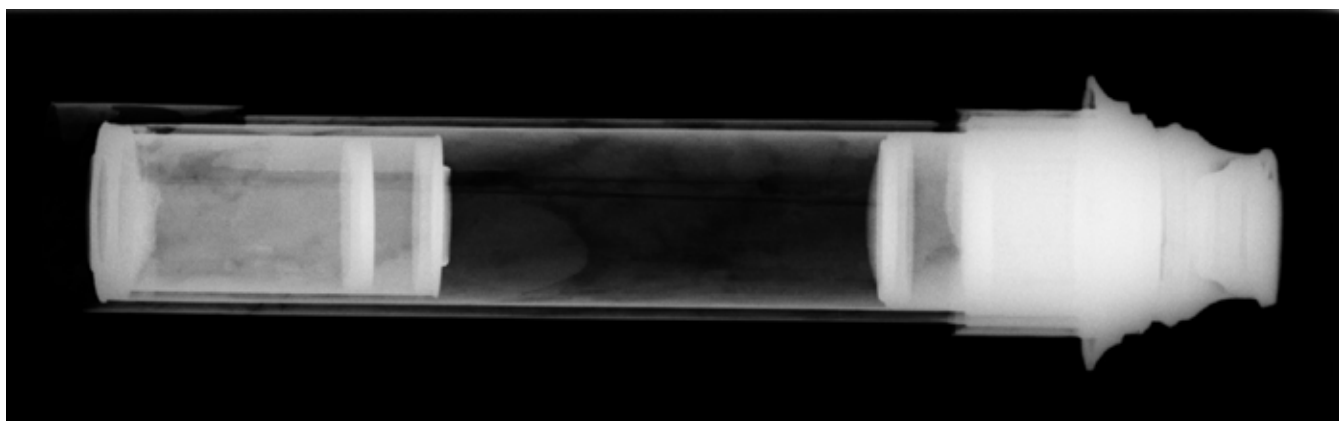
Figs. 81-83. One-draw cupreous telescope BC-05-00031-NL before and after conservation and in x-ray (L. 24.2cm).

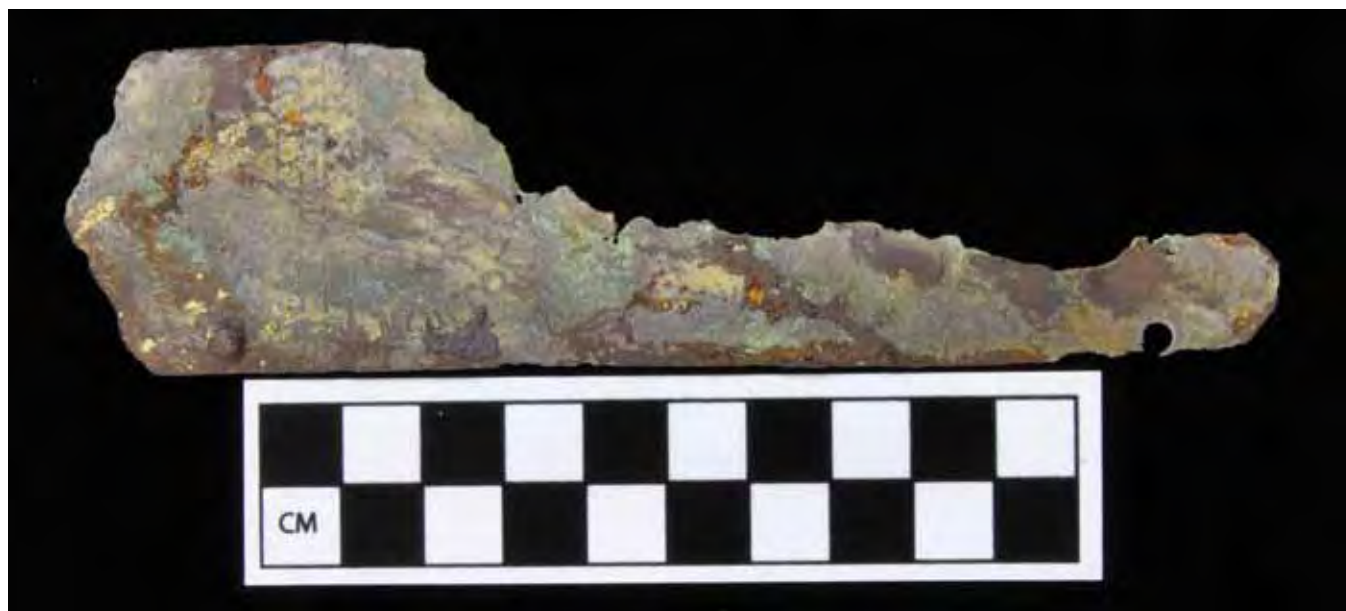
Fig. 87. Brass plaque BC-05-00210-ML from the front of a spring-loaded hanging 'Morton & Bremner' scale (L. 15.0cm).

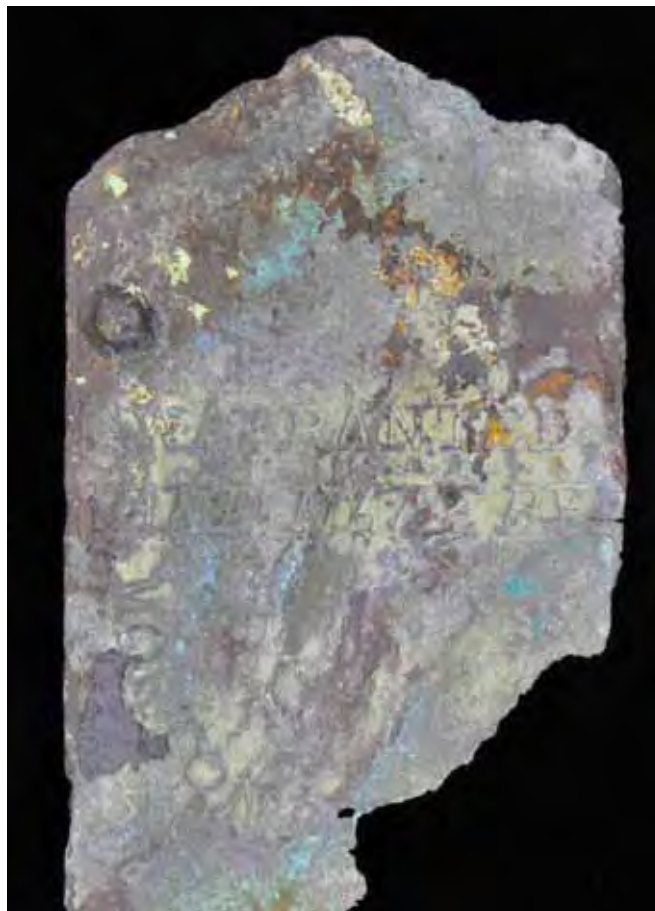
Fig. 88. Detail of brass plaque BC-05-00210-ML from a weighing scale inscribed "WARRANTIED AND MADE BY MORTON &..." for Morton & Bremner of New York (L. 15.0cm).

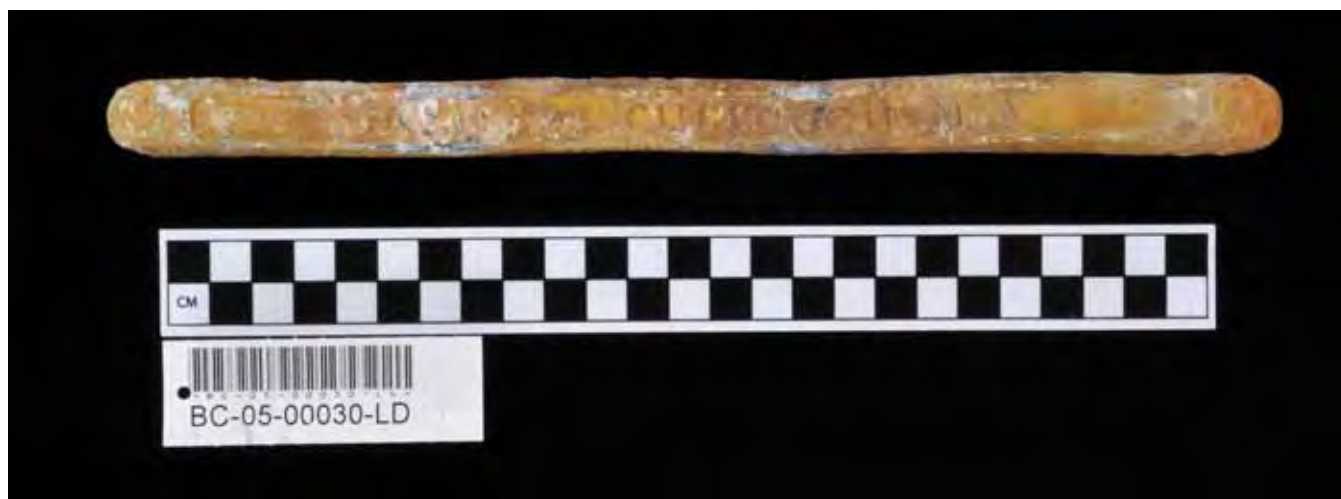
Fig. 91. Lead bar ingot BC-05-00030-LD bearing the mold-impressed name of 'James McCullough. N-Y' (L. 27.0cm).

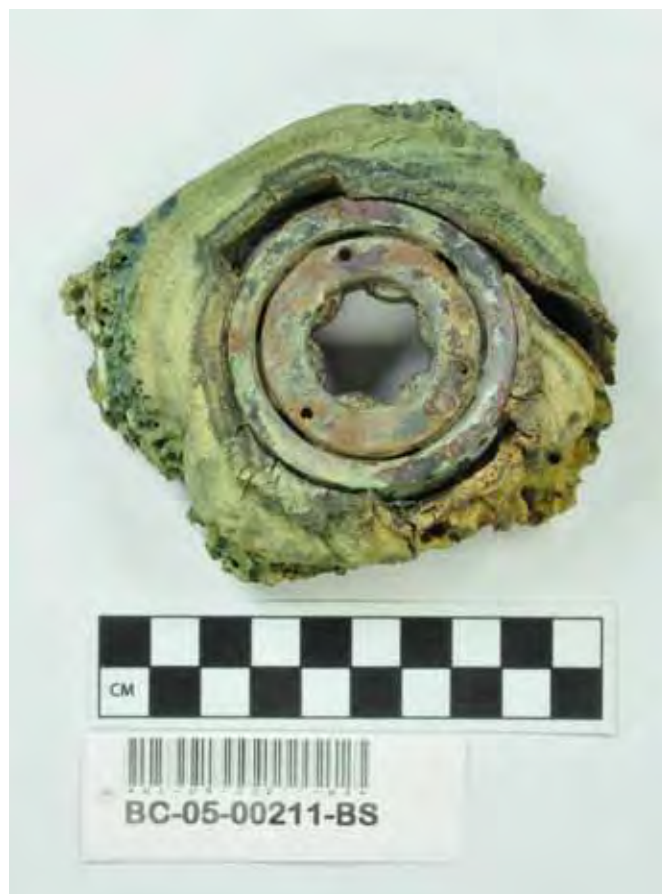
Fig. 101. Wood and cupreous bearing BC-05-00211-BS (L. 10.8 x 9.9cm).

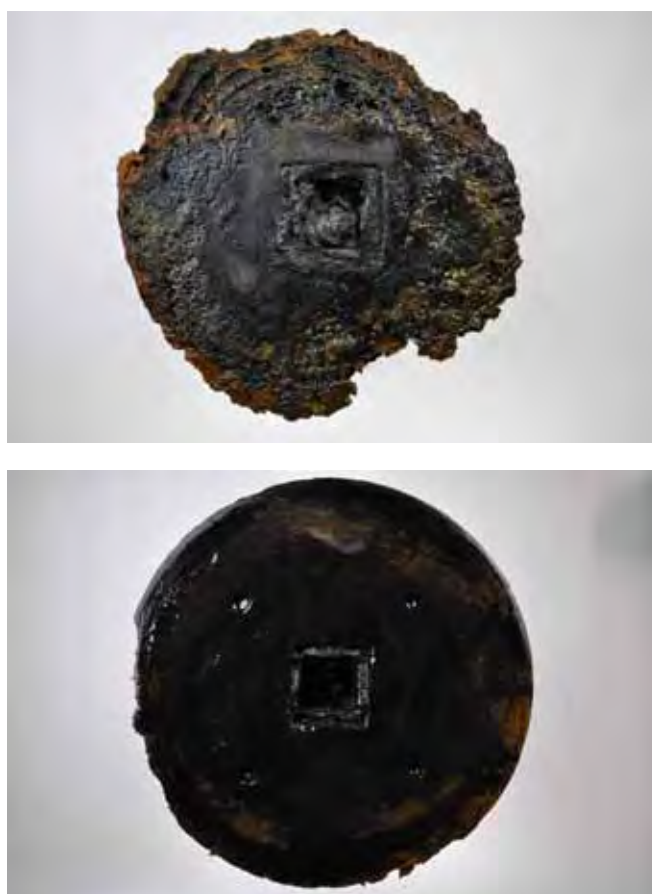
Fig. 102. Composite wood/iron hatch roller BC-05-00402-SF from the bow area of the wreck (L. 23.4cm).

Two heavily degraded mushroom-shaped composite wood/iron hatch rollers were recovered from the southern end of the wreck, 1.5m southeast of the concentration of shell-edged earthenware in Area A (Figs. 6, 44). The original cap survives in place on just one example. Each is pierced with a square hole extending along the central axis from the base to the bottom of the cap. BC-05-00403-SF is 22.7cm long and 17.7cm wide at its single preserved end, with a diameter midway down its length of 7.7cm (Fig. 103). Its central square shaft is 3.2cm wide and lined with a 0.25cm-thick veneer of iron. Four circular nail holes on the base of the preserved end measure 0.5cm in diameter and are set 3.4cm inward of the outer edge. Circular friction marks caused by repetitive rotation are visible at this end.

and both its central barrel and opposite end are heavily degraded (Fig. 102). It measures 23.4cm long and has a diameter of 17.6cm at the intact end. The central square shaft running vertically down the middle of the roller is 3.4cm wide with a 0.33cm iron interior lining. The four nails staggered 3.7cm inwards of the base edge each measure 0.8cm in diameter. Concentric friction marks caused by repetitive rotation are again present on the base.

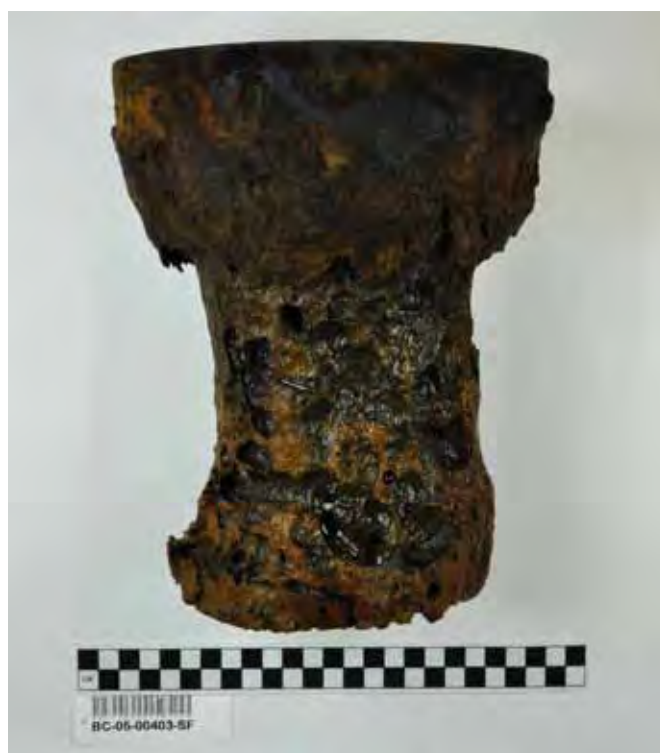
Fig. 103. Composite wood/iron hatch roller BC-05-00403-SF (L. 22.7cm).

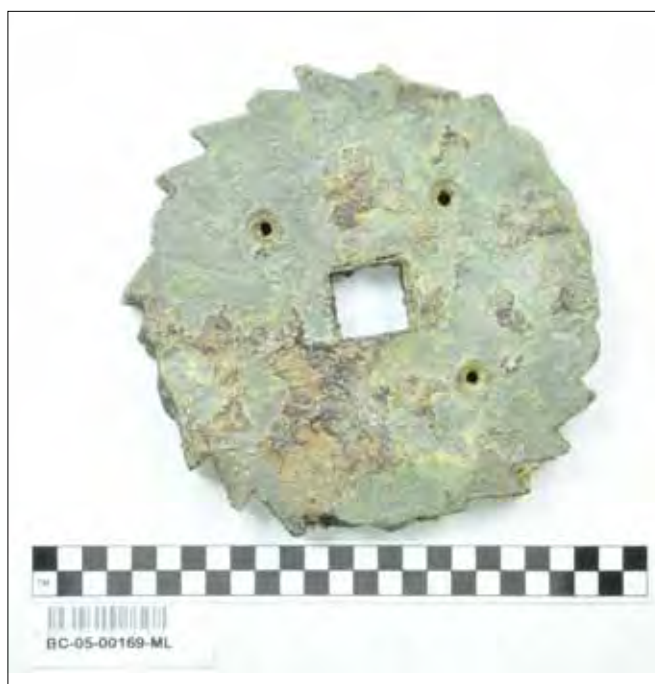
Fig. 104. Wood and graphitized iron hatch roller base BC-05-00169-ML (Diam. 19.2 x 18.9cm).

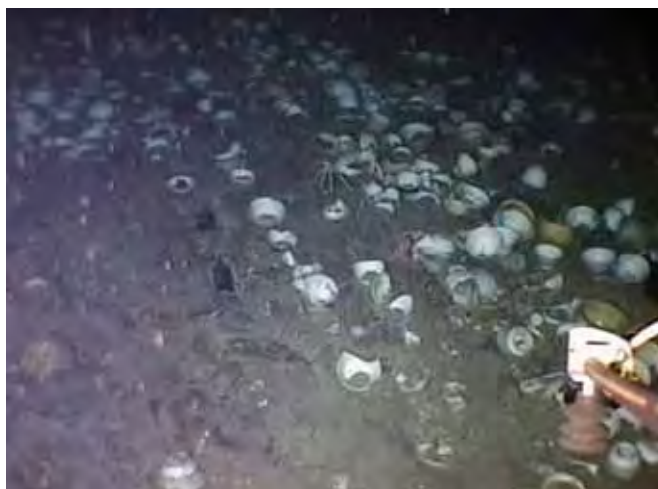
Fig. 119. Lines of ceramics apparently cleared by trawl doors running north/south across Area G on Site BA02.

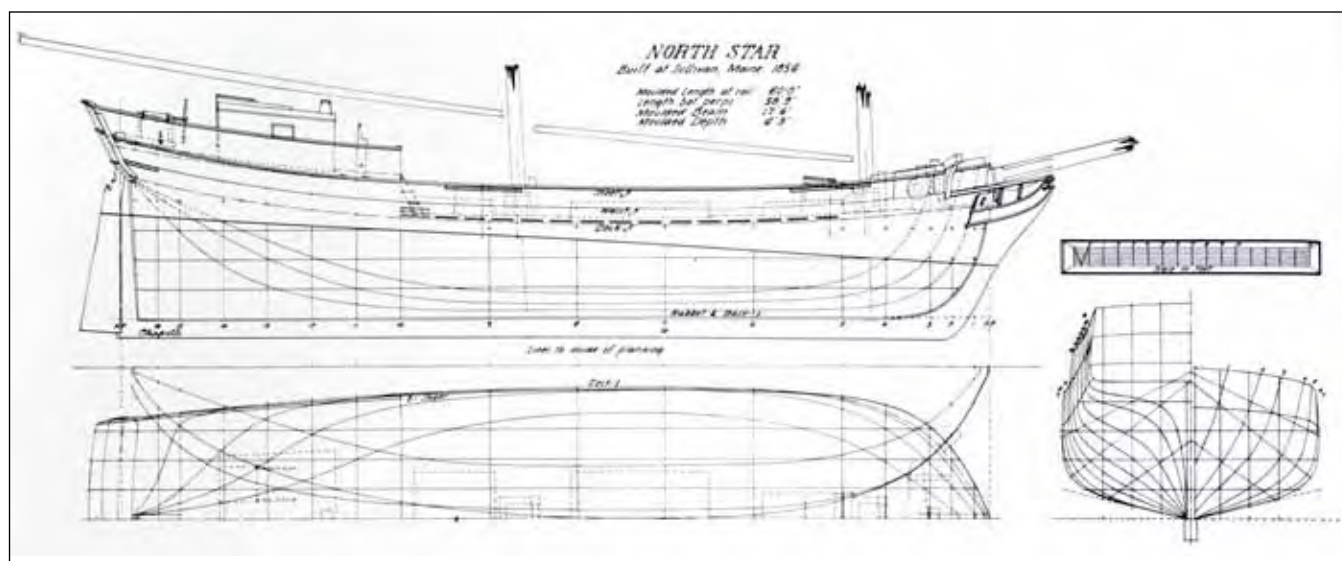
Fig. 121. Lines of the two-masted schooner North Star built at Sullivan, Maine, in 1856 (from Chapelle, 1960: 76).
