## The HMS *Sussex* Shipwreck Project (Site E-82): Preliminary Report

In December 2005 and January 2006, Odyssey Marine Exploration conducted a comprehensive pre-disturbance survey and limited trial-trench excavation on a shipwreck near the Straits of Gibraltar as part of the HMS *Sussex* Shipwreck Project. The site, designated E-82, lies in international waters in the Mediterranean Sea at a depth of 821m in the Straits of Gibraltar.<sup>1</sup> The research was undertaken within the framework of an agreement between the project sponsor, Odyssey Marine Exploration (OME), and the Her Majesty's Government of the United Kingdom (HMG), which has exercised its sovereign right to claim ownership of the wreck of HMS *Sussex*. This report introduces the technology utilized and the environmental and archaeological results obtained during the first deep-sea shipwreck excavation in the Mediterranean Sea.<sup>2</sup>

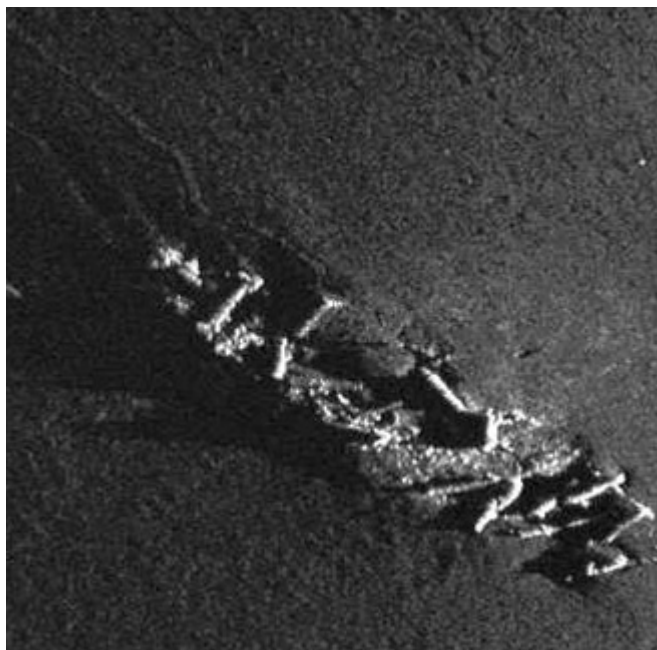
Fig. 1. Side-scan sonar of shipwreck site E-82.

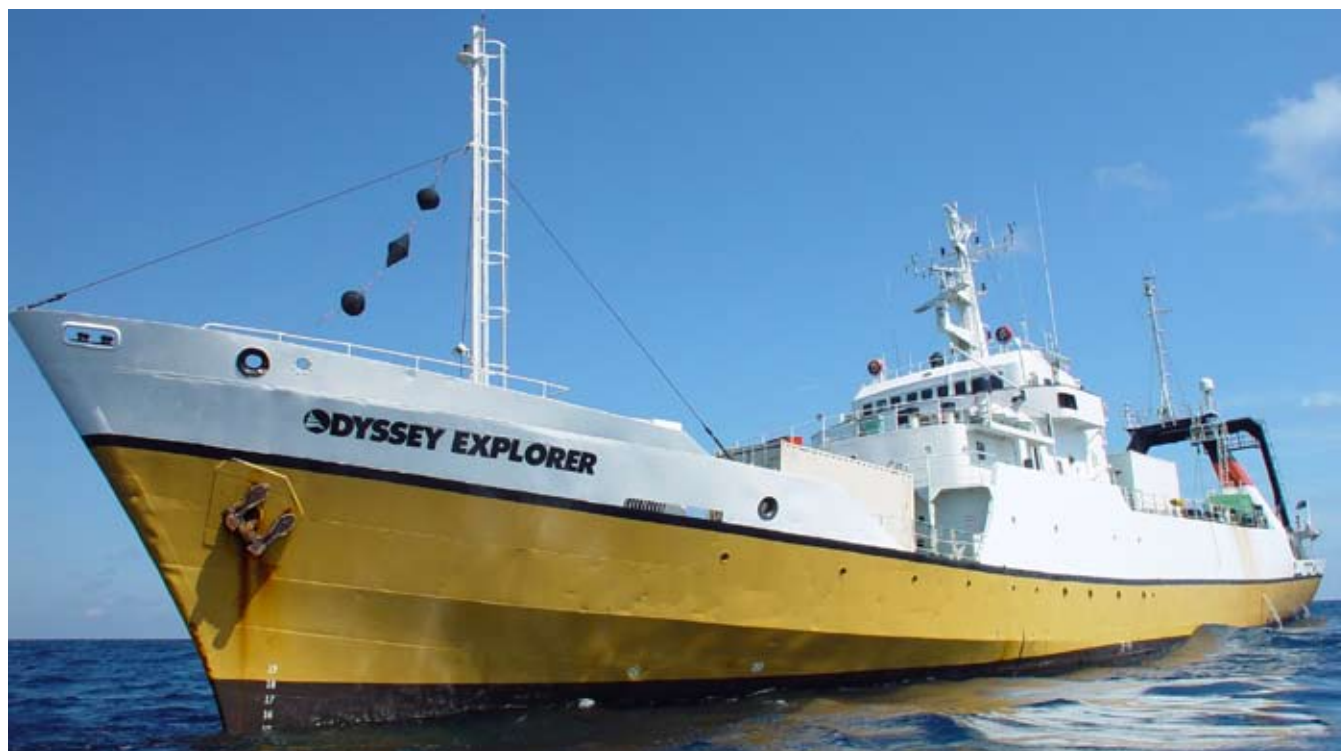
Fig. 2. Odyssey's research platform during the *Sussex* shipwreck project, the 76m-long, 1431-ton Odyssey Explorer.

Odyssey's research platform during the *Sussex* shipwreck project was the 76m-long, 1431-gross-ton *Odyssey Explorer* (Fig. 2). This ship is fully-equipped to support deep-sea exploration and is classed to Ice Class 3 for operations in extreme latitudes. It has accommodation for a crew and staff of 41 people and contains deck-mounted deployment capability, umbilical cable and recovery equipment suitable

for the operation of a work-class ROV system. The *Odyssey Explorer* has the ability to work offshore without re-supply for 60 days.

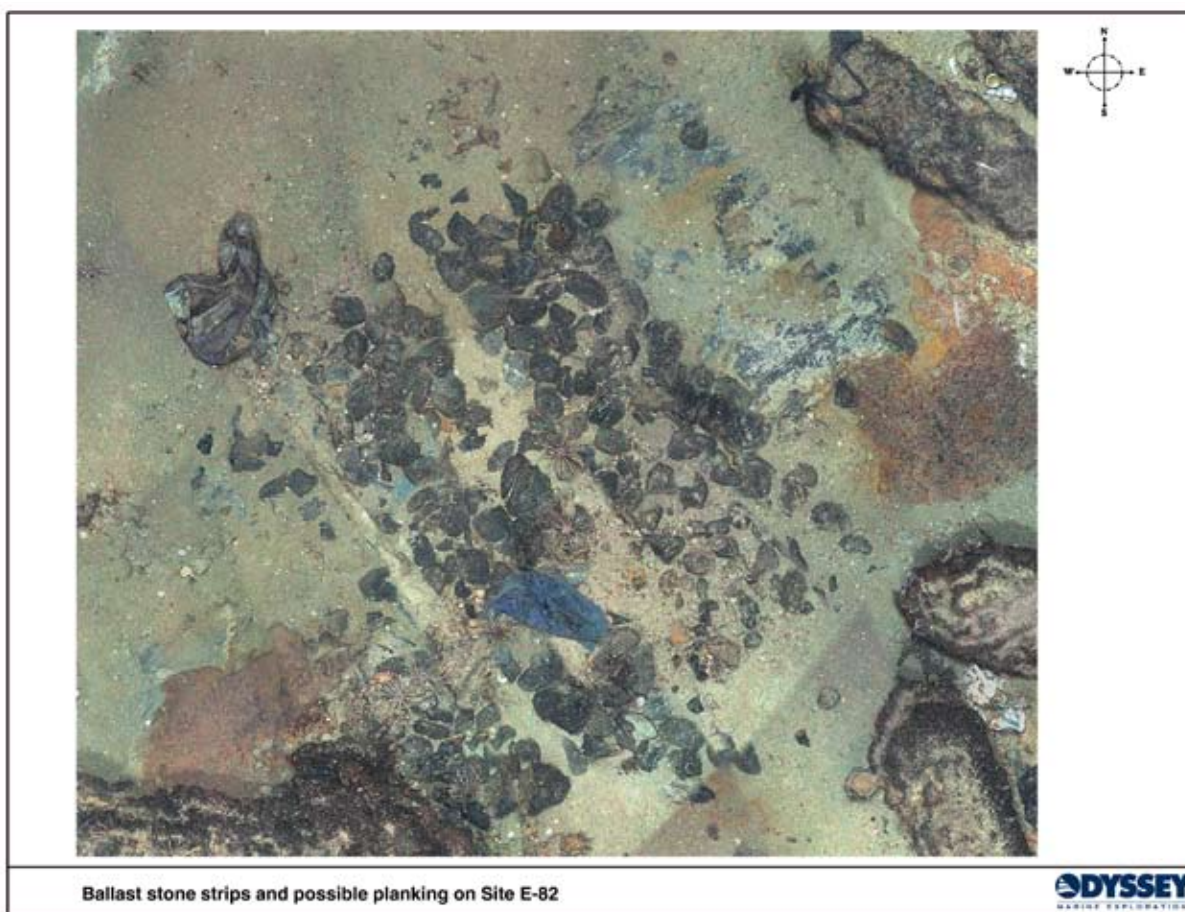
Fig. 6. Possible ballast stones and planking on the north-western side of the wreck.

north-western flank of the wreck site (Figs. 6, 12). A second scattered cluster of stones extends to the south-east.

during light surface ‘dusting’ between the possible ballast stones and cannon C13 on the north-western side of the wreck (Fig. 6). Extending beneath the stones, this feature may represent either ceiling planking or strakes within the lower hull (see below). Horizontal and parallel plank edges seem to extend in a south-west to north-east direction parallel to the main longitudinal axis of the wreck site. At least 11 possible planks are visible, while an identical surface discolorization south-west of the ballast stones may denote their continuation. An unusual feature observed between these possible ballast strips, to the north-east and south-west of the central cluster, are clearly defined linear voids running parallel to the main orientation. Both of these lines are not covered by stones and, in the case of the southern void, sharp edges define its length. These 15cm-wide ‘ghost’ recesses may occupy the locations of decomposed frame stations or riders.

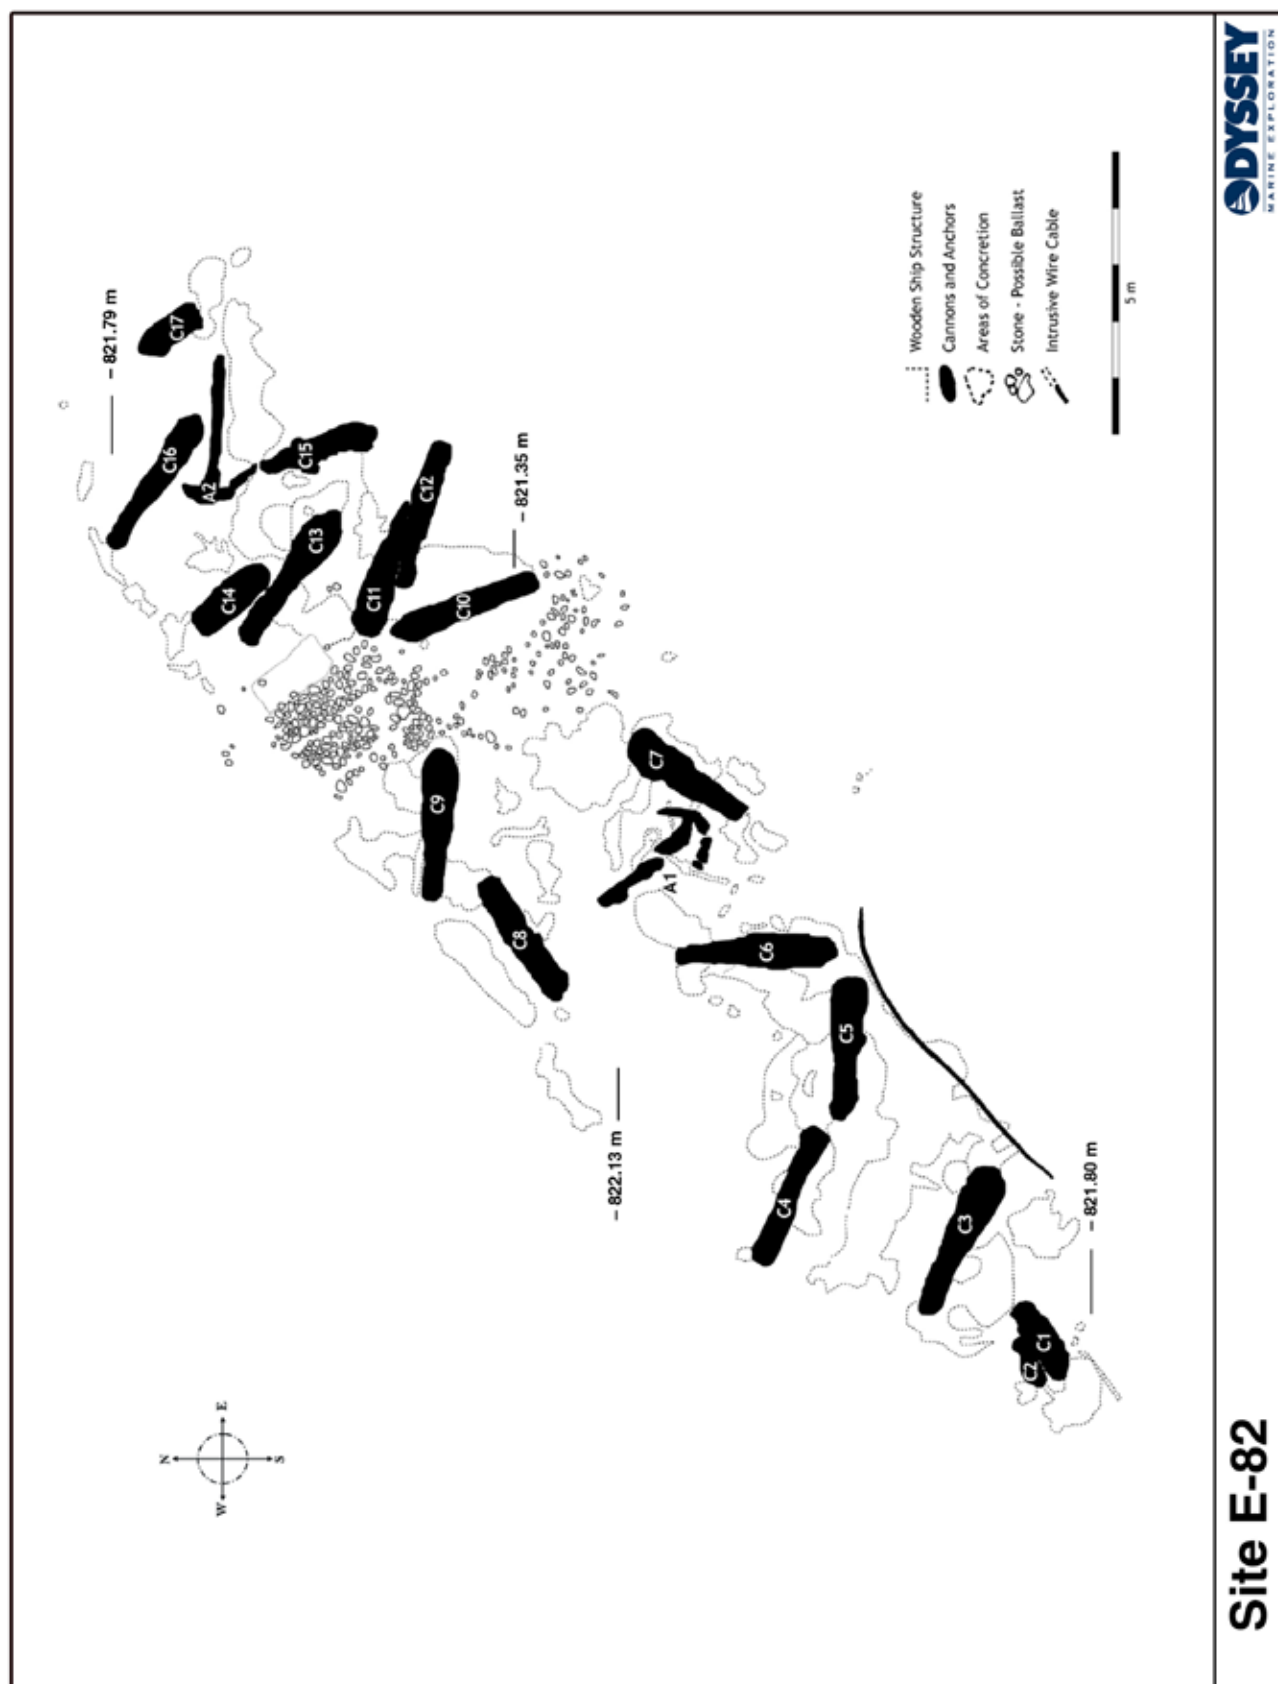
Fig. 12. Master plan of shipwreck site E-82.

The bathymetric survey exposed a largely flat seabed gently sloping to the north-west by 3°, with a maximum amplitude of some 2.32m across a 60 x 30m core area centered on the wreck. The average depth of the site is -821.7m, with a maximum amplitude of 0.78m across the visible wreck. The shallowest area lies at -821.35m to the north-east in the vicinity of cannon C10. The deepest area of the wreck is located on its western flank at -822.13m (Fig. 12).

Site E-82 contains 17 visible cannon (Figs. 7, 11, 12), while concretions identified 1m west of cannon C8 and between cannon C3 and C4 may represent additional buried guns. Several hard obstructions detected close to the visible wreck mound during the environmental coring program probably represent additional examples. These iron guns can be divided into three categories based on recorded lengths: cannon of less than 2m length, which are either partly buried or fractured; longer than 2m, but less than 2.5m long; in excess of 2.5m long (Table 2).

Two concreted iron anchors and a possible anchor fluke characterize the surface of site E-82 (Fig. 12). Anchor A1 lies midship on a north-west to south-east axis, with its arms to the east and ring preserved to the west. Its shank is 2.3m-long, the arms 1.4m-wide and the ring's diameter about 40cm. The arms are broadly bowed, with indistinct palms, while the anchor in general, especially the shank, is extremely delaminated and corroded. The seabed around

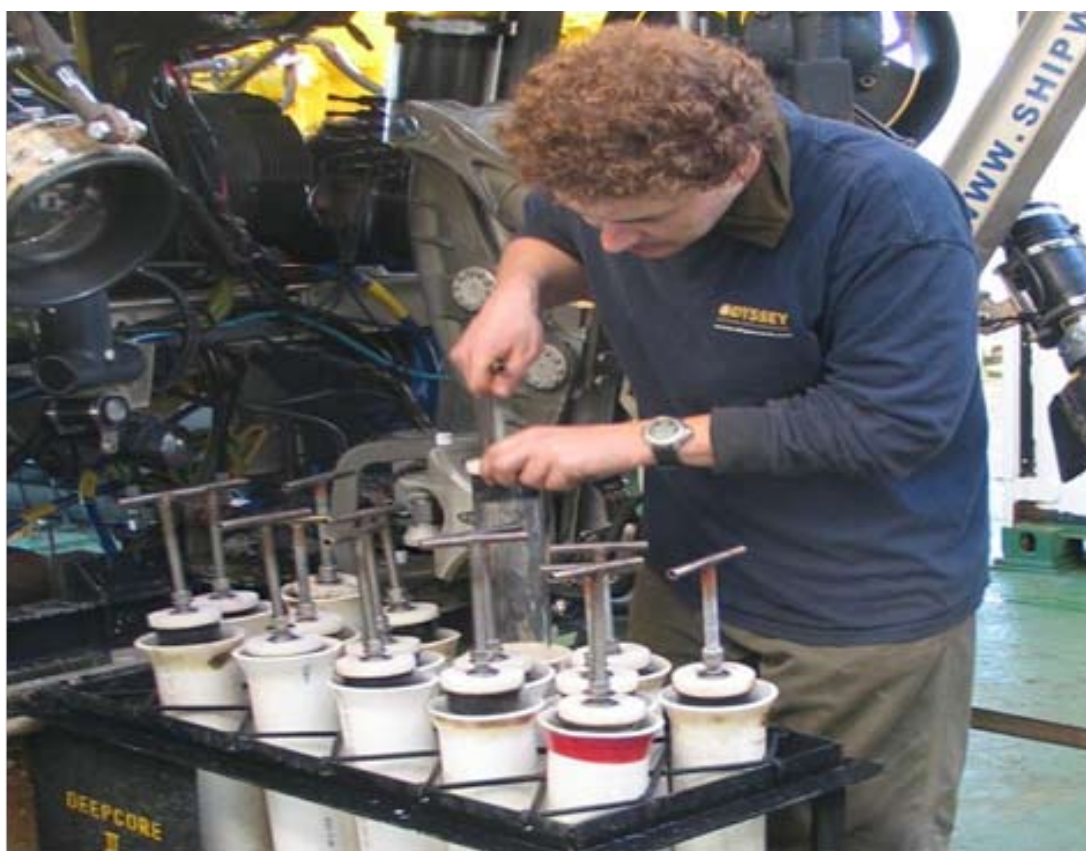
*Fig. 15. Preparing environmental core tubes for descent onto the wreck.*

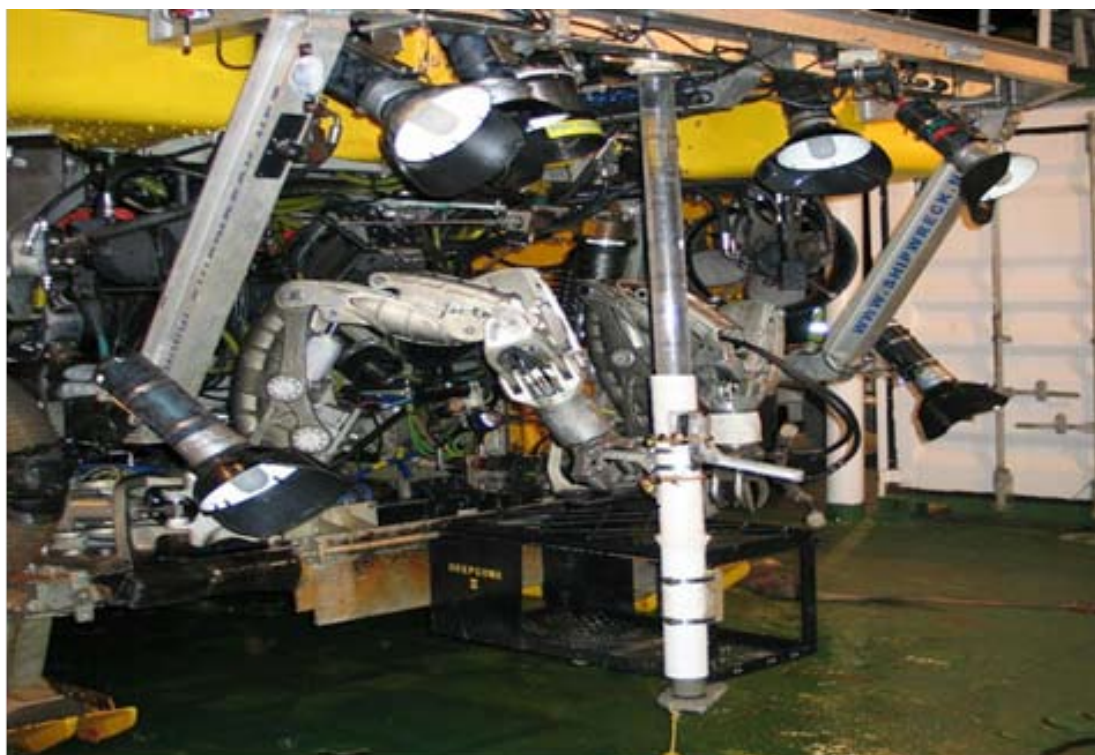
*Fig. 16. A 2m 'long core' installed on ROV Zeus for descent onto the wreck site.*

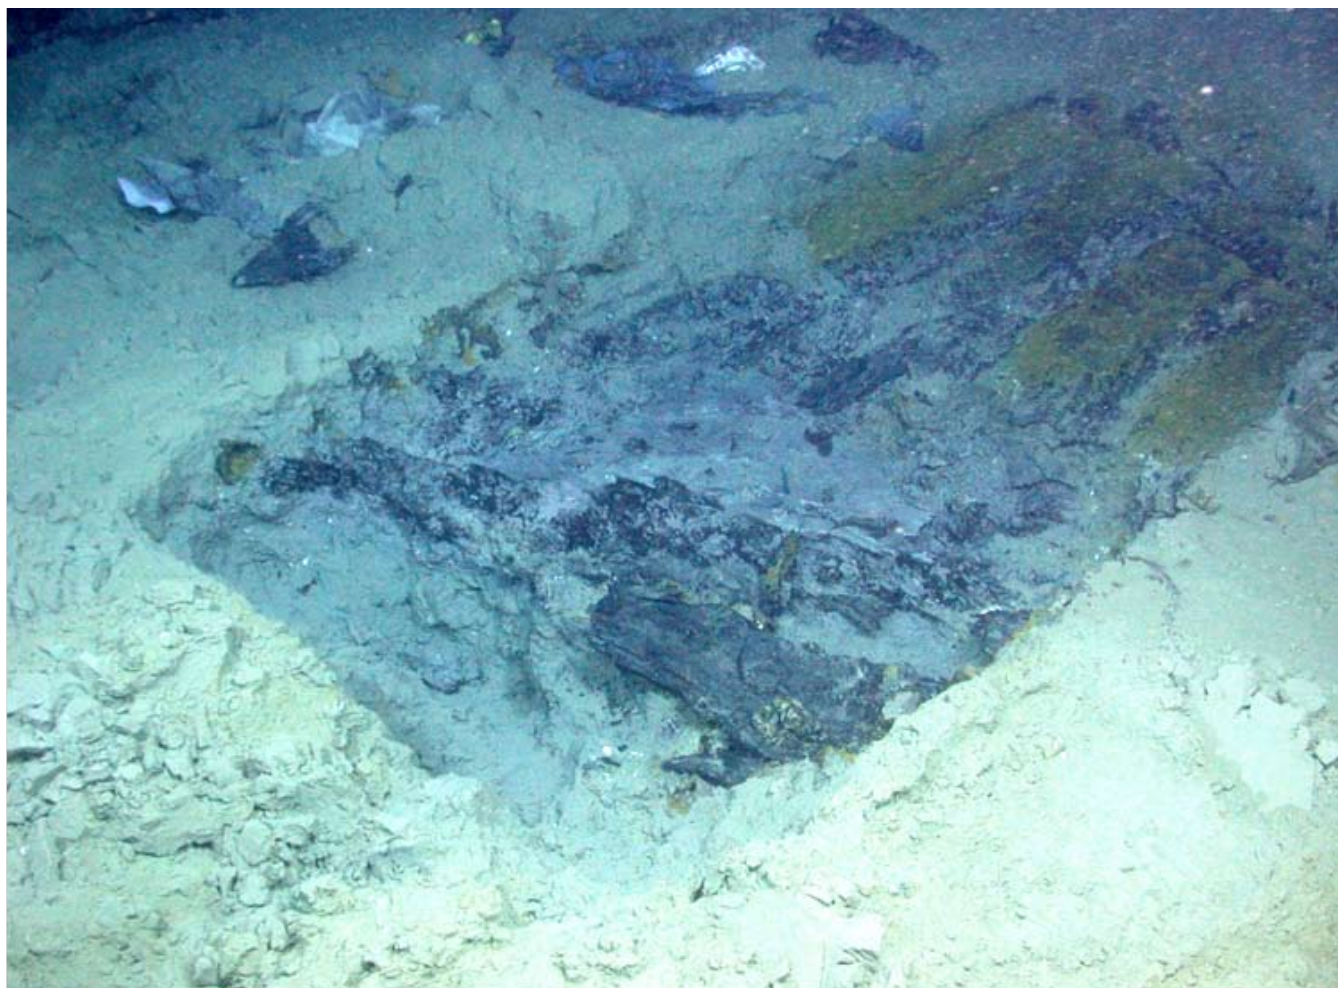
Fig. 23. Frames and possible stringers (at right in foreground) exposed in Trench 3.

Trench 3 seems to contain four frames, each sided 28cm wide, spaced 18cm apart and extending in a north-west to south-east direction out of the northern face of the trench. Three-quarters of the way southwards, the trench is intercut by two extensive longitudinal timbers, most probably identifiable as stringers, over 40cm wide, which are positioned at an angle of about 65 degrees in relation to the frames and extend in a south-west to north-east direction. Artifacts recovered during the excavation of Trench 3 consisted of eight potsherds, six nail concretions, a fragment of rope and fired brick.
