## The Deep-Sea Tortugas Shipwreck, Florida: Technology

Between 1989 and 1991 Seahawk Deep Ocean Technology of Tampa, Florida, conducted the world's first robotic excavation of a deep-sea shipwreck, in this case lost in 405m off the Tortugas Islands in the Florida Keys, USA. The study of this merchant vessel from the 1622 Spanish *Tierra Firme* fleet required the development of cutting-edge technological solutions ranging from an appropriate research ship to a sophisticated Remotely-Operated Vehicle. The latter was custom-tooled with a specialized pump and suction system, which included a limpet device to lift delicate artifacts and a Sediment Removal and Filtration (SeRF) filtering unit to save small finds recovered during the extraction of sediment spoil. The Tortugas shipwreck's technology package successfully enabled 16,903 artifacts to be recorded and safely recovered.

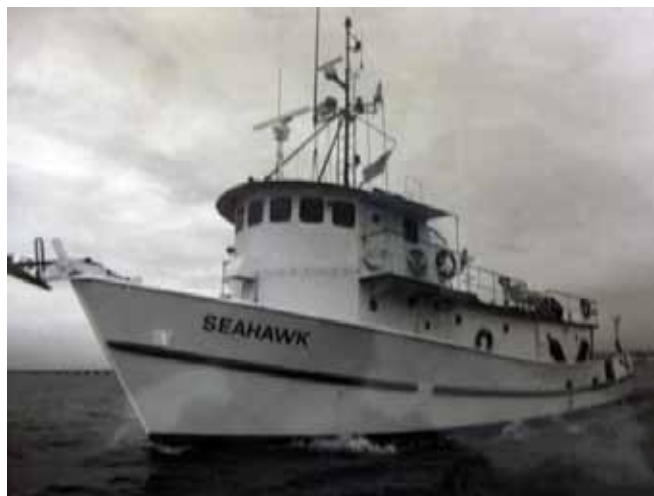
Fig. 1. The 86ft-long research vessel RV Seahawk.

The operation's platform used during the Tortugas shipwreck survey was the 26.2m-long research vessel *Seahawk* (Fig. 1), equipped with side-scan sonar, sector-scanning sonar, magnetometer, a multi-target acquisition/tracking system, an integrated navigation system, Remotely-Operated Vehicles, HF, VHF radios and a very long range cellular telephone. The integrated navigation system was capable of generating search grids and graphically displaying the real time position of the research ship. The side-scanning sonar (consisting of a Klein 590 paper recorder, a 100/500 khz towfish, a Sintrex high-resolution magnetometer and an EG & G magnetometer), a Mesotec 971 and UDI sector-scanning sonar, a Loran C Integrated Seatrac Navigation System, and a Track Point II Dynamic Relative Positioning System facilitated the initial survey.

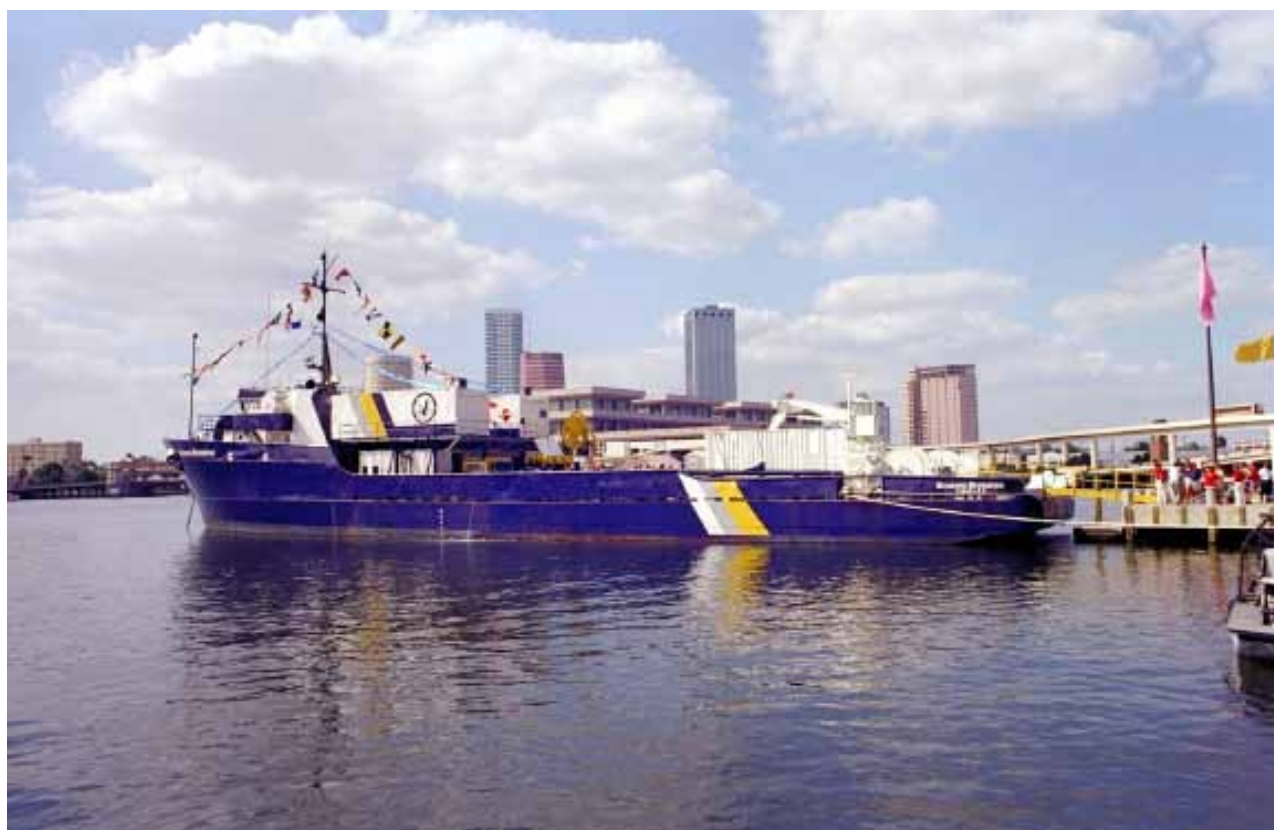
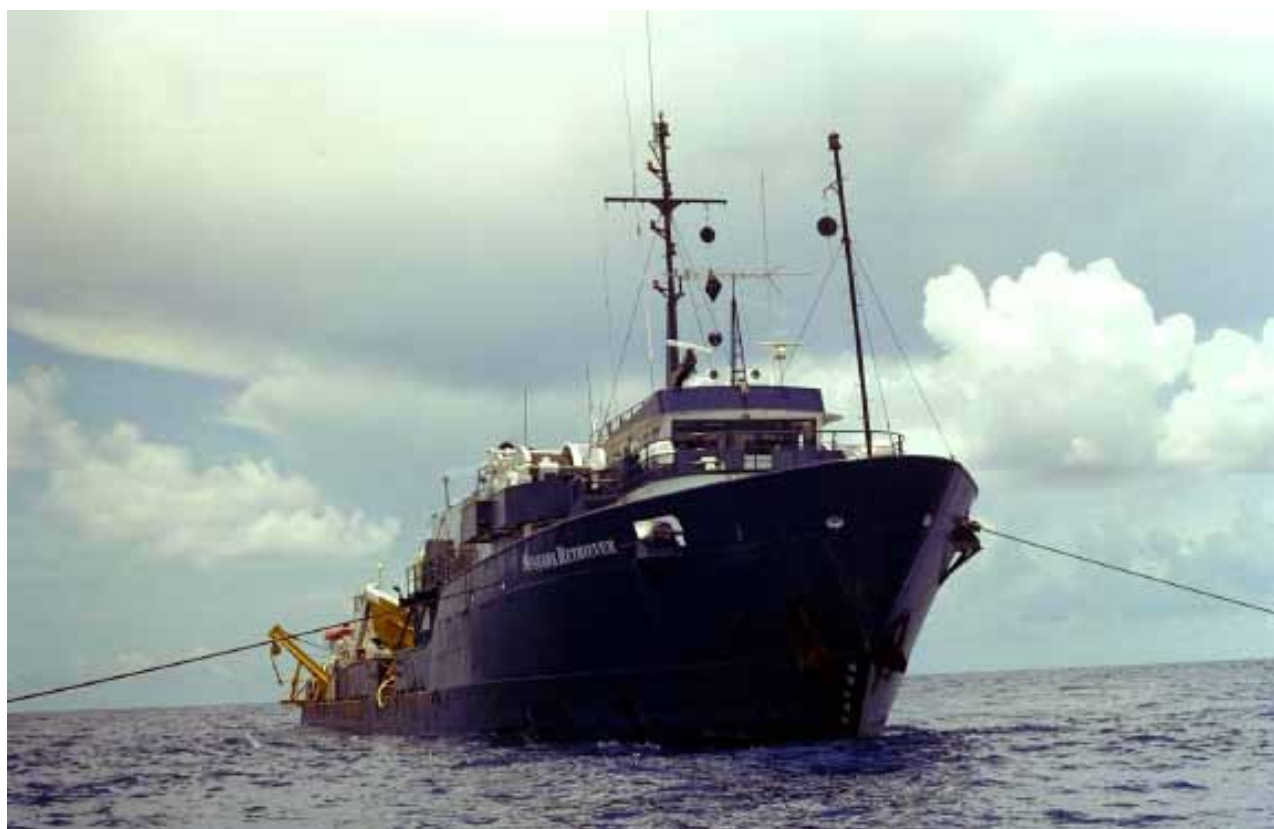
*Fig. 2. The Seahawk Retriever in port. Photo: John Astley.*

*Fig. 3. The Seahawk Retriever anchored over the Tortugas shipwreck site on a four-point mooring. Photo: John Astley.*

In order to commence excavations with suitable technology, a second vessel, the 64m-long *Seahawk Retriever*, was dispatched to the site in May 1990 (Figs. 2-3). Originally called the *Tera Tide*, this vessel was built in 1974 by Burton Shipyard, Texas, as a twin screw supply vessel for transporting and pump drilling mud in the oilfields of the Gulf of Mexico. Of welded steel construction, and with a flush deck aft and raised deck forward, a model bow, square stern and steel deckhouse, the ship was retro fitted for the Tortugas shipwreck excavation with low pressure Bratvaag winches for managing a four point mooring system (Fig. 3), cranes for hoisting equipment and artifacts, a billeting module for housing additional personnel, a complete suite of communications and security technology and a control module for the ROV. The *Seahawk Retriever* was equipped with living facilities for a 30-person crew (Appendix 2).

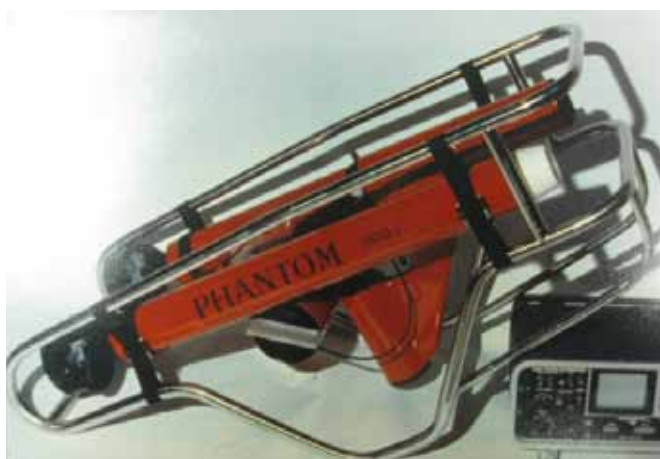
Fig. 4. A DOE Phantom 300 ROV used for visual reconnaissance from the RV Seahawk.

a mid range ROV. Finally, a Phantom 300, with a depth rating of 90m and color video, functioned in shallow water (Fig. 4). The RV *Seahawk* was capable of holding station under its own power without anchoring by 'liveboating' the vessel during ROV operations.

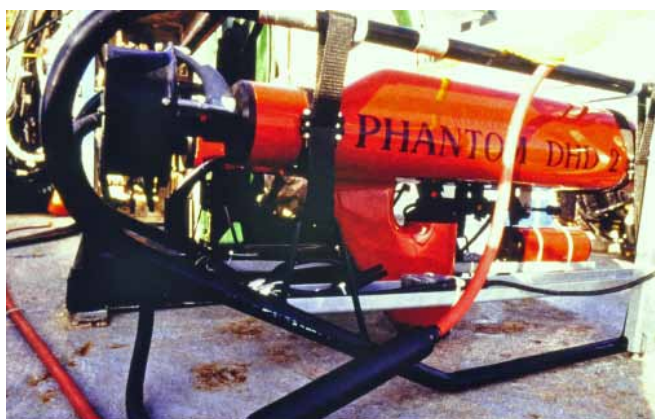
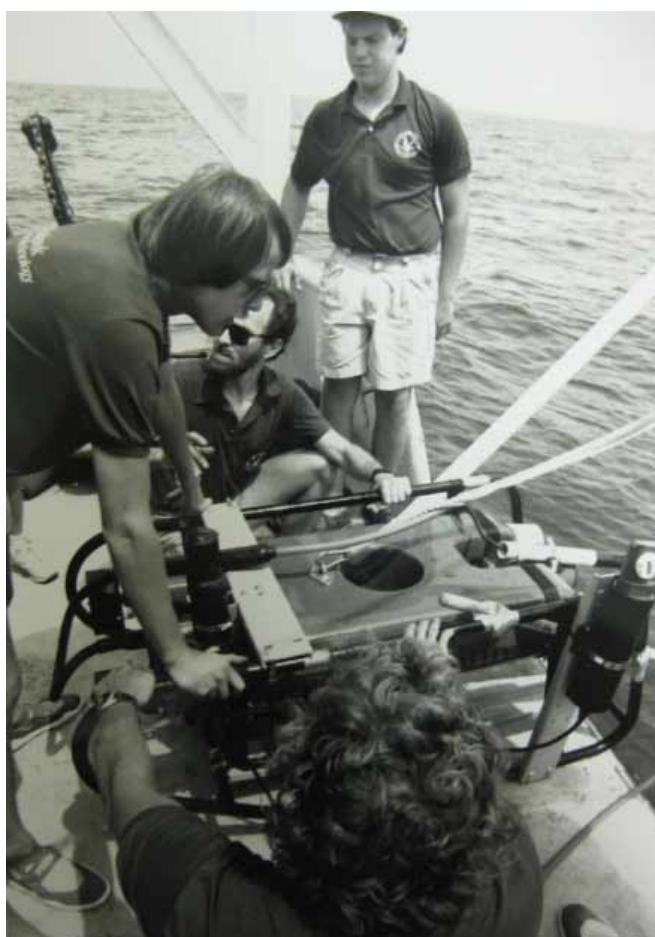
Figs. 5-6. The initial visual wreck survey was accomplished using a Phantom DHD2 ROV (top) being launched by Scott Stemm, Dr. James Cooke, David Six and Steve Dabagian.

Initial visual survey of the wreck site was accomplished using the Phantom DHD2 ROV (Figs. 5-6), which was equipped with a Mesotech 971 sector scanning sonar and was utilized to define the location and perimeter of the site. The ROV was linked to *Seahawk* via 610m of shielded 42 separate conductor umbilical cable (no single wire multiplex control system was available in 1990-91) and was fitted with two 250-watt halogen lights and two Panasonic CCD low light video color cameras to illuminate the site. The Phantom DHD2 had a single function manipulator arm to provide dexterity for the retrieval of artifacts and was equipped with an ORE multi-beacon, which emitted an analog signal received by a Trac Point II tracking system. DHD2, with dimensions of 0.6 x 0.9 x 1.2m,

including its protector bars, weighed approximately 68kg and was propelled by six thrusters. The pilots flew the ROV using a 'joy stick' control and observation via a small TV monitor mounted in the control console. A 'co-pilot' managed the camera adjustments, recorders and manipulated the retrieval arm.

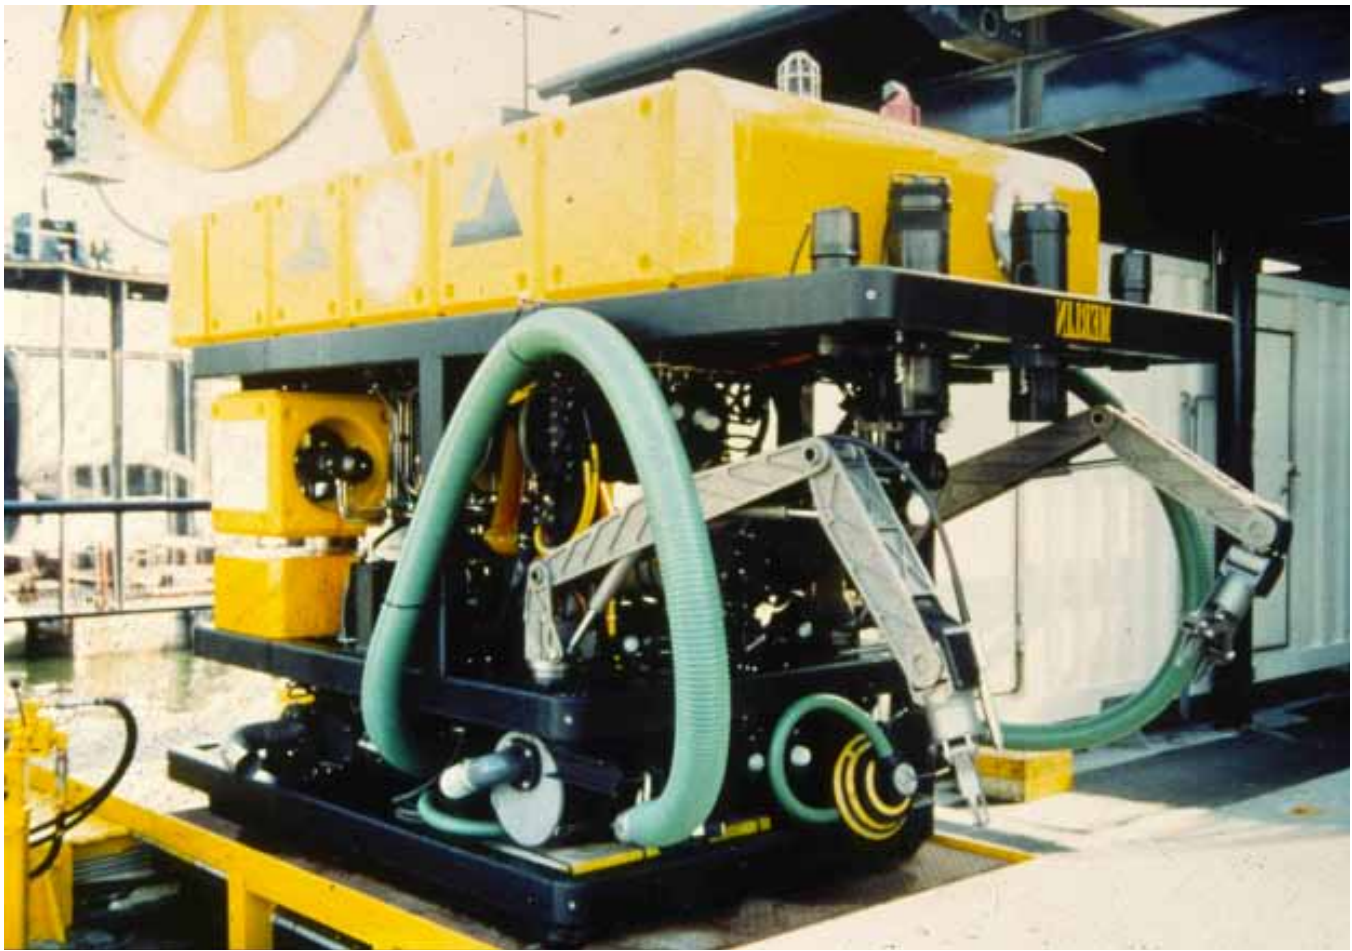
Fig. 7. The 3-ton ROV Merlin built for the Tortugas shipwreck excavation; with its SeRF system hose and nozzle at front right, two manipulator arms and limpet suction device at center. Along the badge bar are two 35mm cameras and two 70mm still cameras.

positioning system and weighed approximately 3 tons out of water (Figs. 7-12). Buoyancy blocks of syntactic foam (to resist the crushing effects of pressure at 400m) made Merlin 272kg positively buoyant. The ROV had six hydraulic-powered positioning thrusters; vertically oriented thrusters allowed it to work above the seafloor without stirring up sand or silt. In other words, Merlin floated and used thrusters to push itself down, which enabled the system to hover safely over the site. Thrusters also held the ROV steady when artifacts were lifted. Either manipulator arm could lift up to 113kg without affecting Merlin's position in the water. One of the manipulators used a master/slave system controlled by a master replica of the manipulator at the surface desk; the jaw pressure could be dialed up to 500lbs or reduced to a few ounces. Positioning was determined and recorded by a system of long baseline transponders installed on the site, which communicated with transponders on Merlin and the ship.

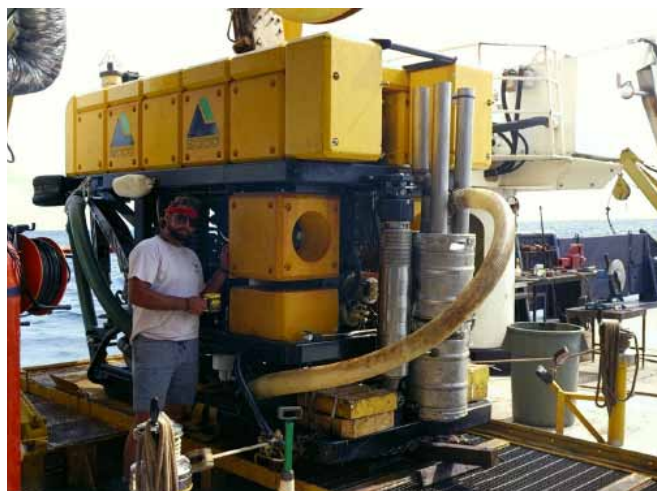
Fig. 9. The SeRF (Sediment Removal and Filtration System) tool for sieving small finds custom-designed for the Tortugas shipwreck excavation and installed onto the rear of the ROV Merlin. Photo: John Astley.

The dredge receiver into which spoil was filtered was constructed from two 18 US gallon stainless steel pressure beer barrels built onto the rear of the ROV Merlin (Figs. 9-11). Its content size was suitable for dredging a cubic meter of clay (about one ton). When full the receiver typically held about 25% clay and 25% hard objects (stones, shell and small finds including pearls, seeds, coins, beads, glass, and human and animal teeth: Figs. 31-32). Simultaneously, nearly a ton of clay had exited via the three exhaust stacks in the form of fine debris that drifted away from site and created no visibility issues.

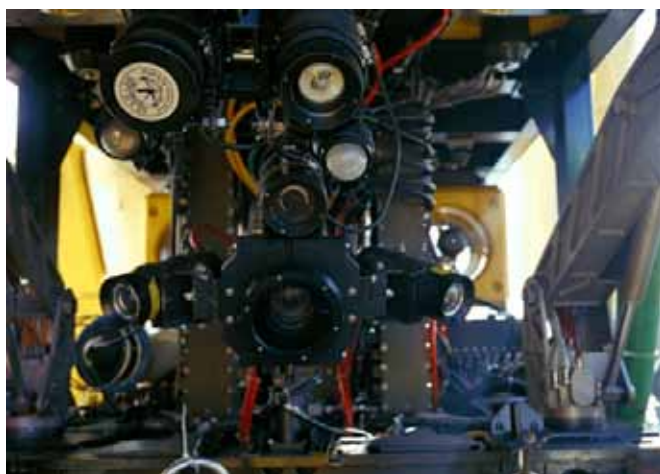
Fig. 8. Cameras and strobe lights at the front of the ROV Merlin. Photo: John Astley.

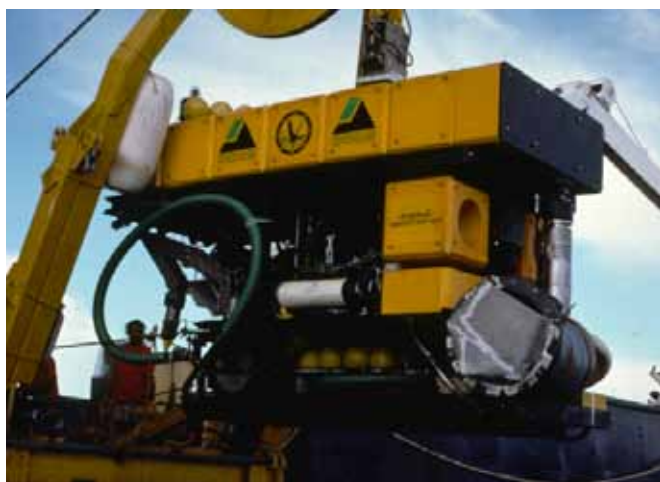
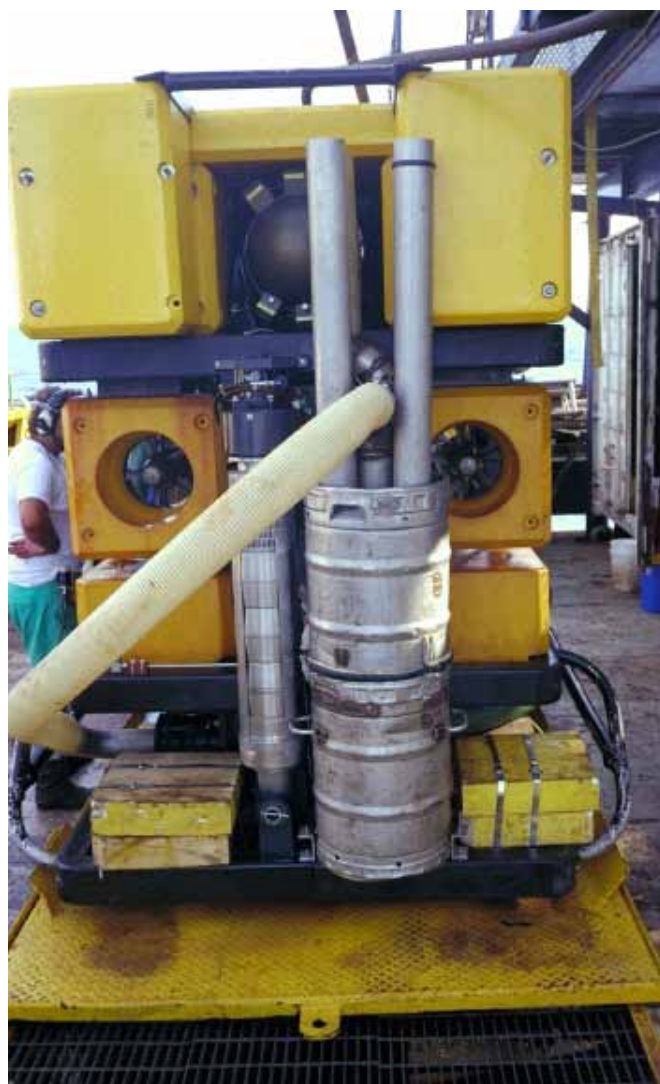
Figs. 10-11. The custom-designed receiver and venturi pump from the SeRF (Sediment Removal and Filtration System) unit installed onto the rear of the ROV Merlin (with an early prototype at top). Photo (Fig. 11): John Astley.

The size of the domed plate proved to be critical and was determined by trial and error. If the dome was too small it allowed too much turbulence in the bottom of the receiver. It was discovered that the best results were obtained by cutting the domed plate a little on the large side so that some clay was retained alongside any artifacts collected. The clearance between the edge of the dome and the receiver rim was 2.5cm. This served to protect and cushion the small artifacts, but demanded more intensive sorting after ROV recovery.

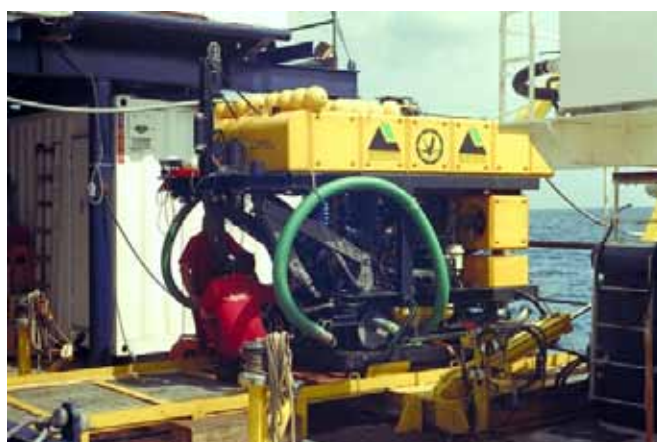
Fig. 12. The ROV Merlin docked onto the deck of the Seahawk Retriever. Photo: John Astley.

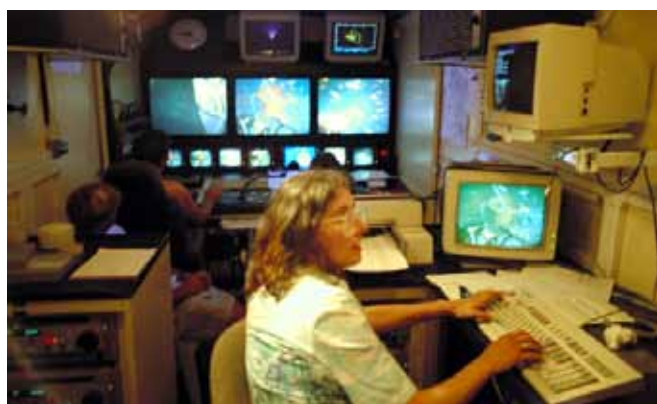
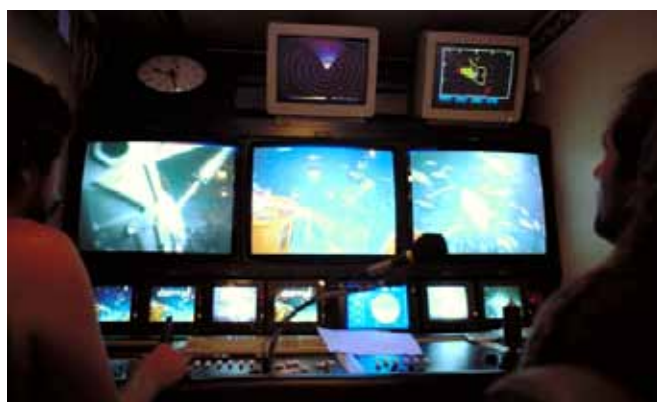
Fig. 13. The archaeological recording and datalogger room on the Seahawk Retriever from where excavations were observed and documented. Photo: John Astley.

Fig. 14. Monitoring archaeological operations on the Tortugas shipwreck from the Seahawk Retriever. The top screens displayed sonar and navigation. The three middle colour screens revealed a very wide view of the site under investigation. The lower row of screens depicted compass, vehicle instrumentation and stern camera data, plus other cameras monitoring the ROV parts. In the foreground the datalogger runs four SVHS recorders and the logging system. Photo: John Astley.

A crew of three technicians operated the ROV from the control room onboard the *Seahawk Retriever* (Figs. 13-14) under the supervision of the project archaeologist. Video was relayed to the control room via fiber optic cable, where three 30in video screens provided a 180-degree view of the underwater excavation site. One Photosea 35mm camera and two 70mm cameras (oriented so that stereoscopic still photos of artifacts *in situ* were possible) provided still photography. Merlin's Schilling manipulators were made of titanium and included a five-function and a seven-function unit. Pilots watched events on the seafloor live in real time on monitors and commanded the manipulator arms using joysticks at the control console aboard the *Retriever*.

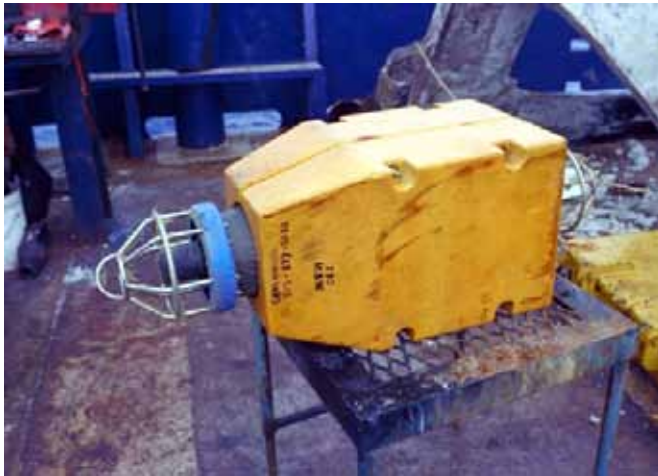
Fig. 15. A Sonardyne transponder, with the transducer at left and the hook release at right, all encased in a buoyancy jacket to facilitate recovery. Photo: John Astley.

The Sonardyne long baseline system used for positioning included a set of transponders that were placed in a seabed array and interrogated by the ROV, or the ship, to obtain positional information. Calibrating arrays of this type and gauging the precise distance between transponders on the seabed had always been an inherent problem. Traditionally this had been executed using transponders that 'ping' (transmit a single tone but no telemetry) and by steaming the ship around the site and interrogating the transponders to compare positions with surface radio navigation systems, thereby obtaining a calibration. This method produced a reasonable result in shallow water, where the temperature and salinity of the local water column was known and in an area where surface navigation facilities were good (bearing in mind that in 1989 GPS was not yet available).

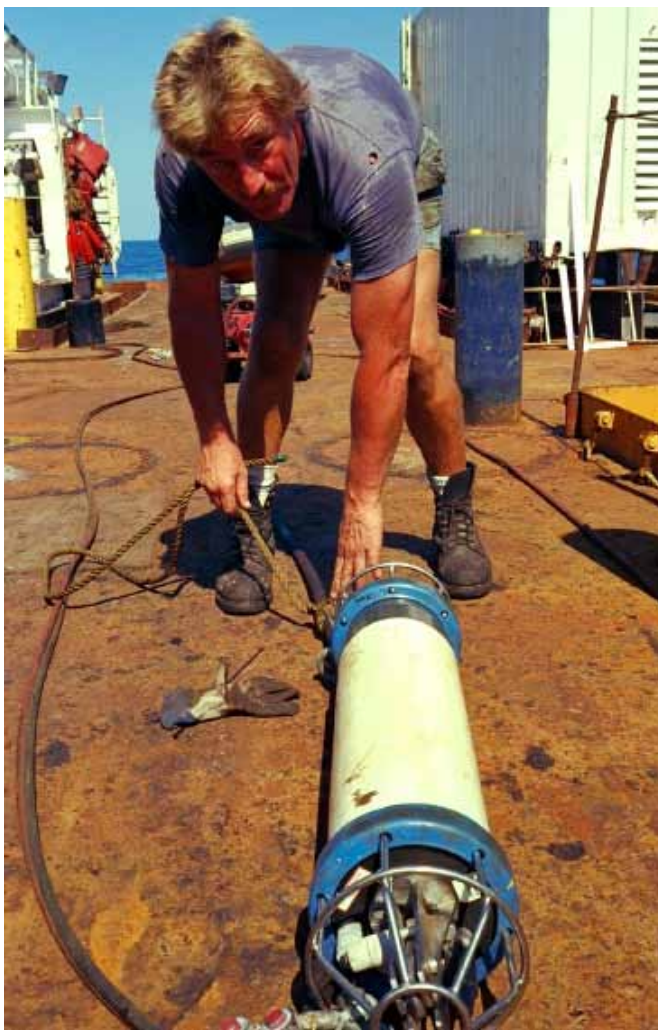
Fig. 16. Alan Crampton rigging a Sonardyne transponder for deployment. Photo: John Astley.

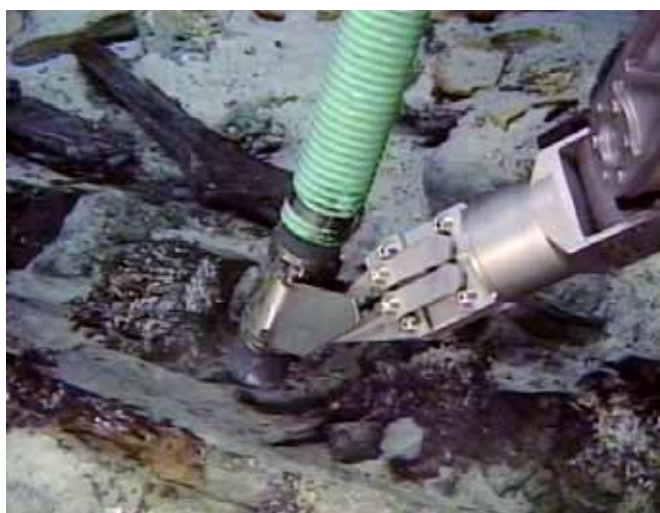
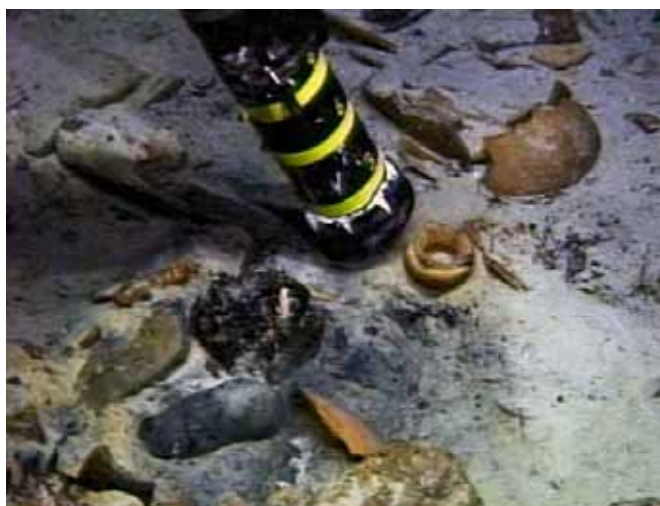
*Figs. 17-18. Removing overburden on the Tortugas shipwreck using the SeRF system.*

The sediment removal and filtration (SeRF) system used on the Tortugas excavation was a 25hp hydraulically-driven three-stage water pump (Figs. 17-18). This venturi pulled water and unobserved small finds through the main system (Fig. 36). No artifacts passed through any mechanical portion of the pump, so there was no damage to cultural remains that might have traversed the system. In addition to working sensitively around archaeological remains, this system could extract solid clay at full power. It could also be reversed to back flush the system or blow away silt and sand.

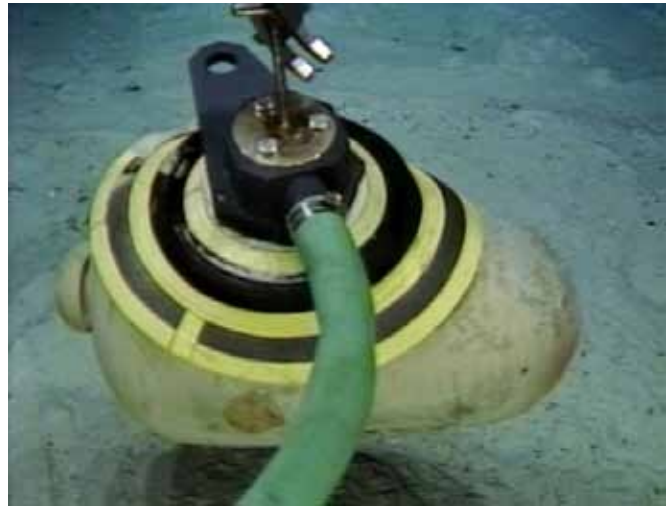
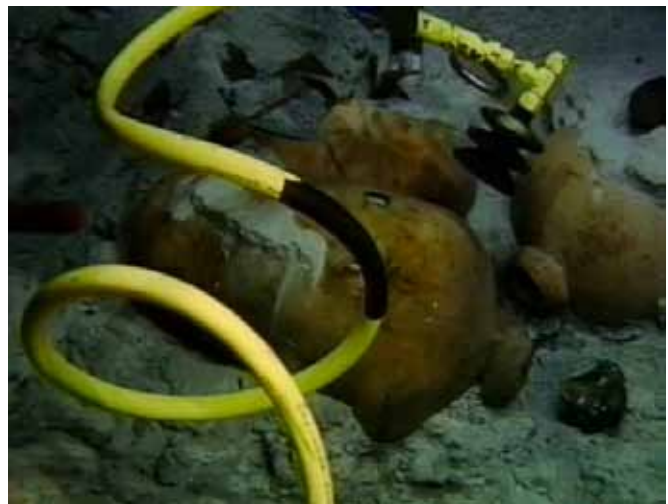
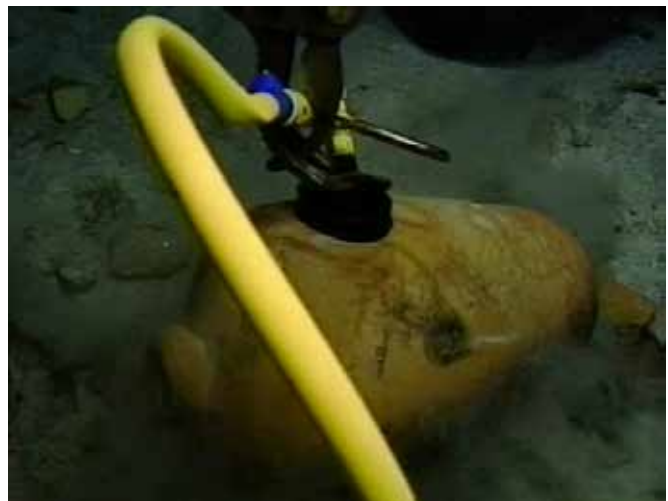
*Fig. 19. An early limpet suction device developed for the Tortugas project being used to recover an olive jar.*

*Figs. 20-21. An evolved small limpet suction bellows device used to recover artifacts from the Tortugas shipwreck inspired from paper printing industry technology.*

Perhaps the most resourceful modification custom-made by the Tortugas team was the attachment to the ROV of a small, 5cm-diameter bellows type suction cup (Figs. 19-21, 36-37). The suction delivered to this device

was controllable by the operator. The cup could pick up the most delicate porcelain and olive jars without causing damage, yet could still remove large angular ballast stones. The invention and adoption of this limpet system on the Tortugas shipwreck went through several phases of on-site development and was the first application of this tool on a deep-sea archaeological excavation. The system is now a standard tool utilized by Odyssey Marine Exploration and other archaeological operatives.

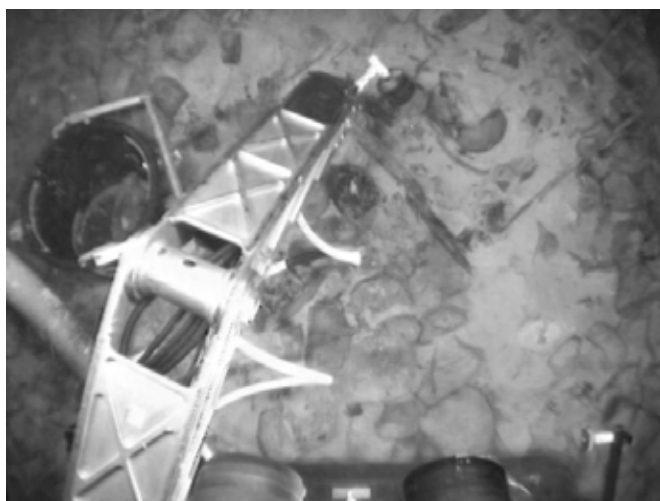
*Fig. 22. Observation of Merlin excavating, using the ROV's vertical black and white still camera.*

*Fig. 23. Observation of Merlin excavating using the ROV's vertical black and white still camera, with its electronic grid position and geospatial data superimposed over the image. Similar data could be observed on all live and recorded video data.*

A Navigation Camera was situated on the front of the ROV that looked down vertically to navigate movements safely. A video overlay system generated a white cross-site in the center of this picture (Fig. 23). The ROVNAV transducer carried by the ROV was fitted just above this camera so its crosshairs were centered directly below the transducer, which provided the known location on the site. This camera served as the vehicle's datum.

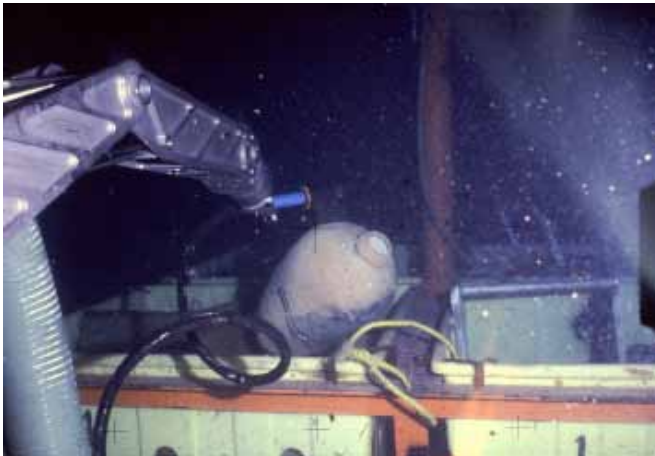
*Fig. 24. An olive jar being secured into a 4Plex unit by the ROV Merlin using its limpet suction device.*

tate carrying by the ROV manipulator arms. The baskets were placed in sectioned off partitions in the large steel basket designed for retrieving artifacts from the sea bottom, nicknamed the 4Plex, which had a lifting capability of 3 tons (Fig. 24).

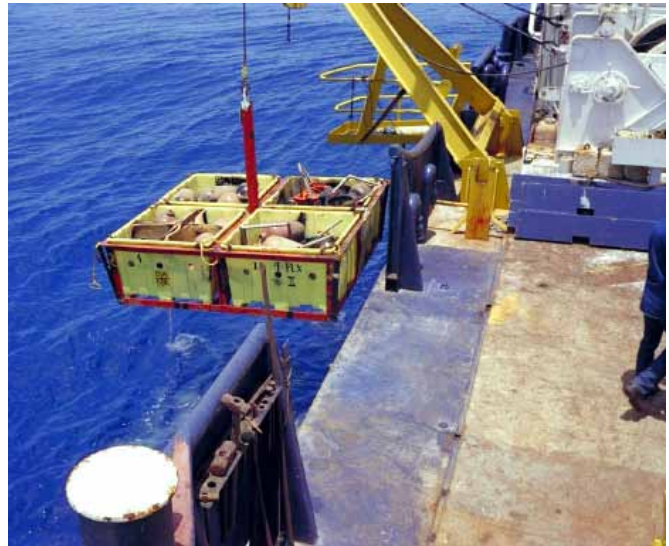
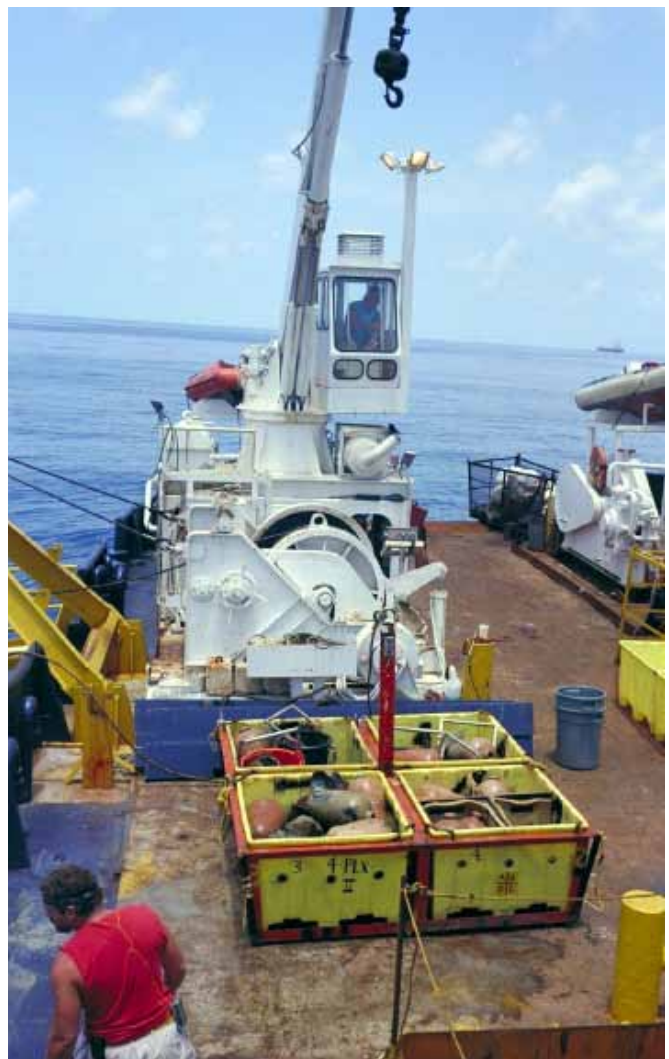
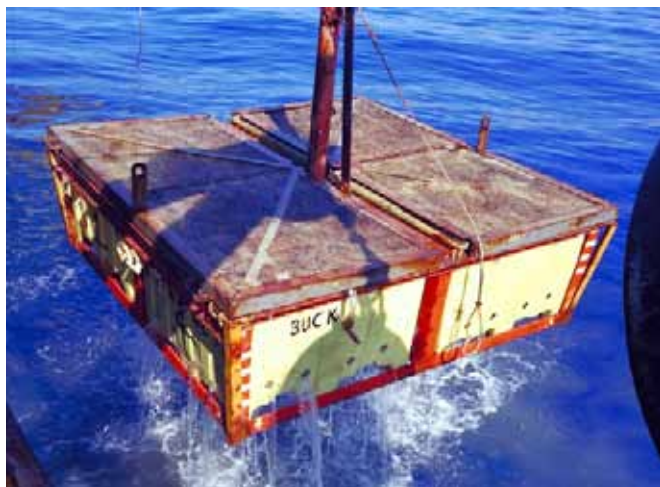
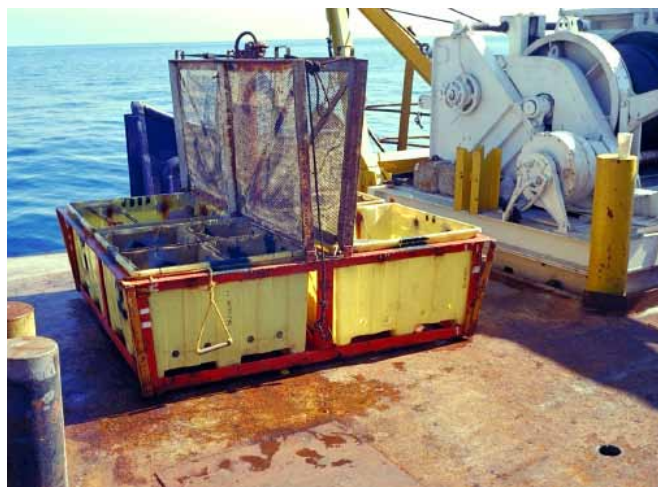
*Figs. 25-26. Artifacts secured in a 4Plex unit being winched onto the deck of the Seahawk Retriever. Photos: John Astley.*

Figs. 27-28. Numbered 4Plex units were recovered with a closed lid protecting the artifacts. Photos: John Astley.

When the 4Plex was ready for recovery, a wire was lowered from the research vessel's recovery winch. Near the hook on this wire was a transponder that enabled the ship to reposition itself using its winches to guide the hook to within 50m of the 4Plex. When the hook arrived near the sea bottom the ROV approached it, grasped it with a manipulator and conveyed it to the 4Plex, where it could be hooked on and lifted to the ship (Figs. 25-30).

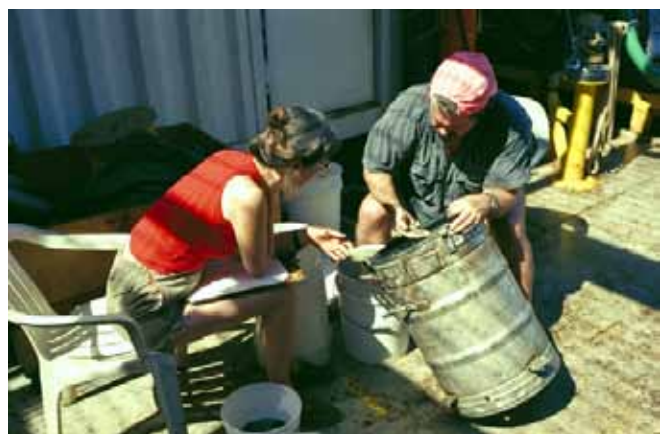
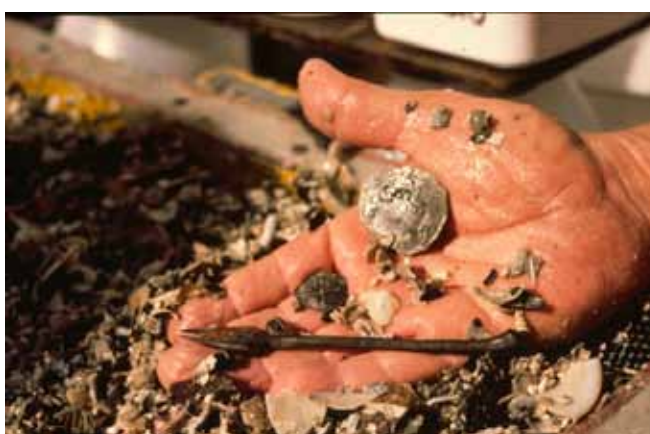
Figs. 31-32. Archaeologist David Moore examines sieved spoil recovered from within the ROV Merlin's SeRF (Sediment Removal and Filtration System) unit. Photo (Fig. 31): John Astley.

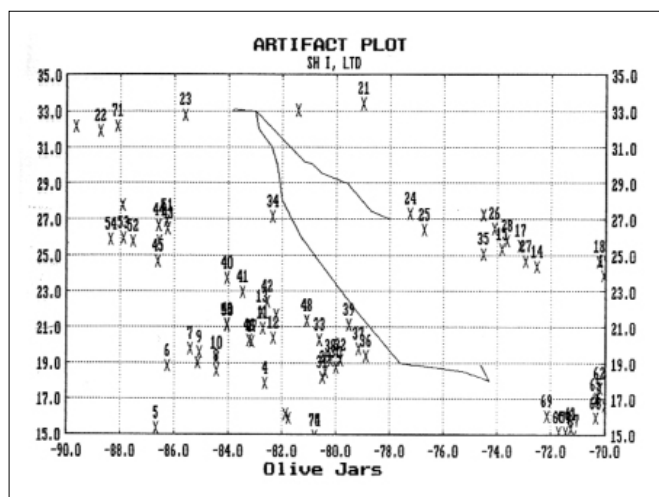
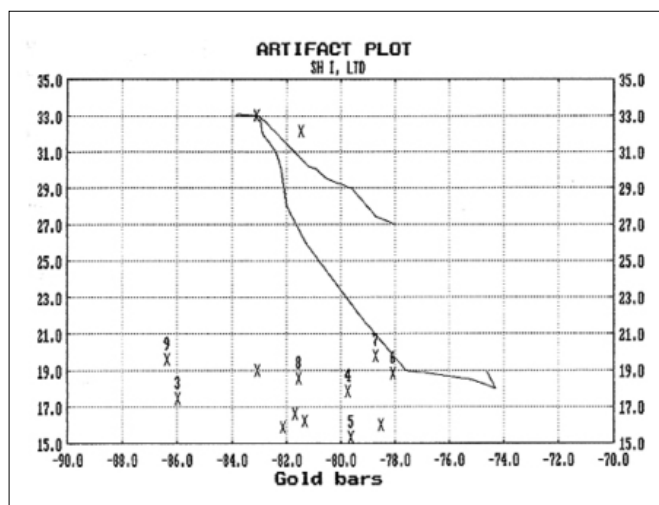
Fig. 34. An example of an original computer generated artifact plot from the Tortugas shipwreck excavation, in this case showing the positions of olive jars.

Fig. 35. An example of an original computer generated artifact plot from the Tortugas shipwreck excavation, in this case showing the positions of gold bars.

The electronic database, stored on computer disc, could be accessed through a variety of methods. For example, a category of artifacts (ie. olive jars) could be imposed on an outline of the site so that the distribution could be studied. Any combination of categories could be plotted together showing their distribution over the site and contextual relationships. The computer could also be commanded to generate a plot (either on screen or paper) showing the distribution of the gold bars, glazed ceramic bowls or astrolabes, for example (Figs. 34-35). These plots proved invaluable in determining relationships between artifacts and site contexts during the course of the excavation – and then to recreate the site through post-processing after the project was completed.
