The Deep-Sea Tortugas Shipwreck, Florida: Technology

John Astley

Greg Stemm

Between 1989 and 1991 Seahawk Deep Ocean Technology of Tampa, Florida, conducted the world's first robotic excavation of a deep-sea shipwreck, in this case lost in 405m off the Tortugas Islands in the Florida Keys, USA. The study of this merchant vessel from the 1622 Spanish Tierra Firme fleet required the development of cutting-edge technological solutions ranging from an appropriate research ship to a sophisticated Remotely-Operated Vehicle. The latter was custom-tooled with a specialized pump and suction system, which included a limpet device to lift delicate artifacts and a Sediment Removal and Filtration (SeRF) filtering unit to save small finds recovered during the extraction of sediment spoil. The Tortugas shipwreck's technology package successfully enabled 16,903 artifacts to be recorded and safely recovered.

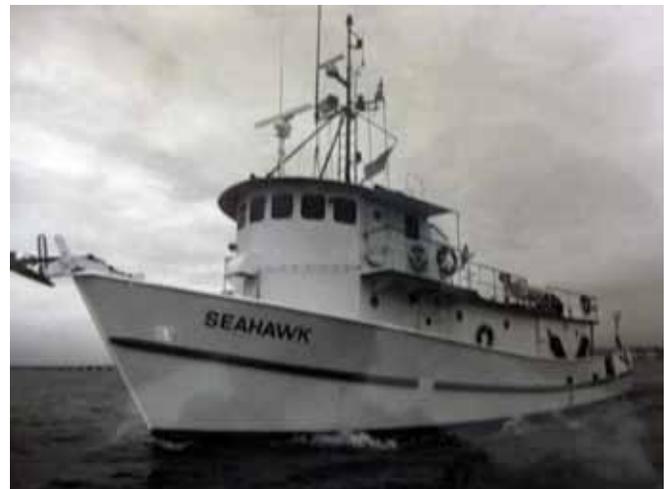
Fig. 1. The 86ft-long research vessel RV Seahawk.

The operation's platform used during the Tortugas shipwreck survey was the 26.2m-long research vessel *Seahawk* (Fig. 1), equipped with side-scan sonar, sector-scanning sonar, magnetometer, a multi-target acquisition/tracking system, an integrated navigation system, Remotely-Operated Vehicles, HF, VHF radios and a very long range cellular telephone. The integrated navigation system was capable of generating search grids and graphically displaying the real time position of the research ship. The side-scanning sonar (consisting of a Klein 590 paper recorder, a 100/500 khz towfish, a Sintrex high-resolution magnetometer and an EG & G magnetometer), a Mesotec 971 and UDI sector-scanning sonar, a Loran C Integrated Seatrac Navigation System, and a Track Point II Dynamic Relative Positioning System facilitated the initial survey.

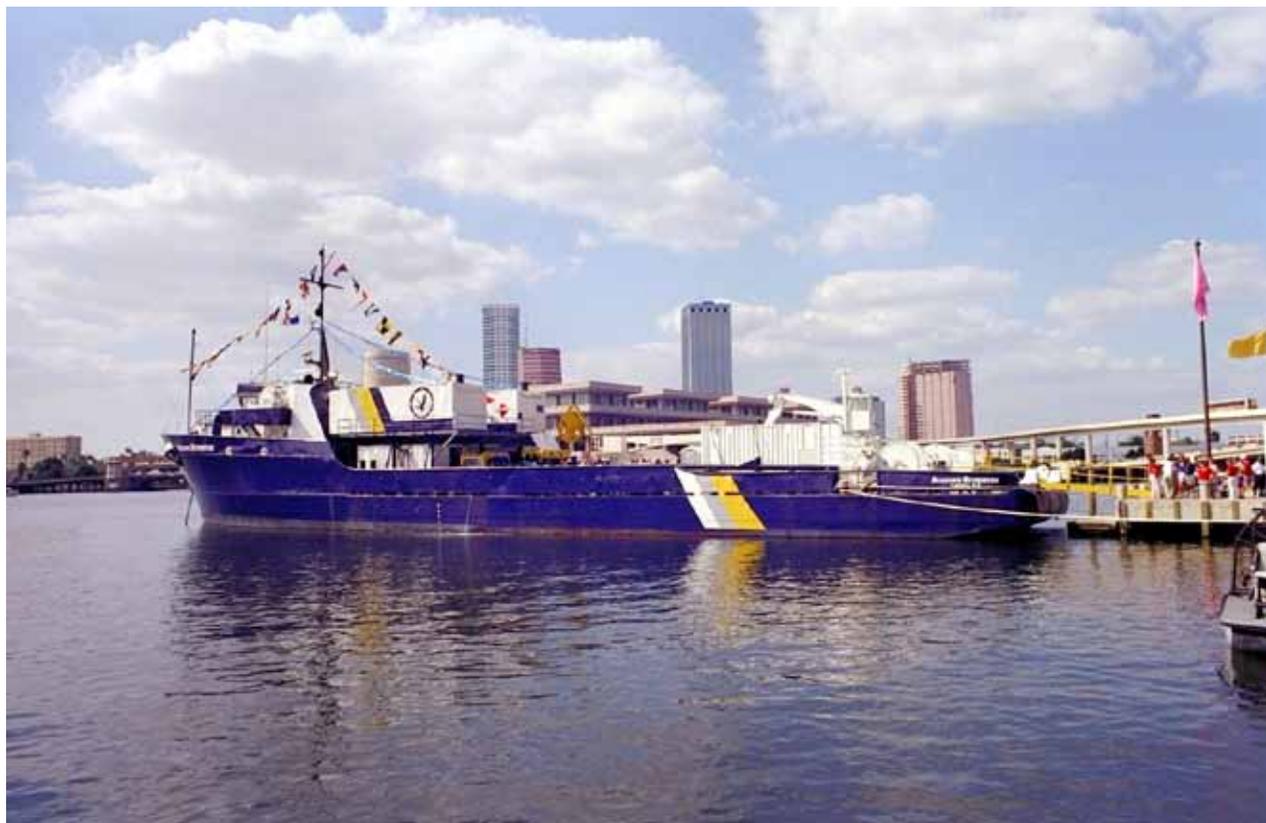
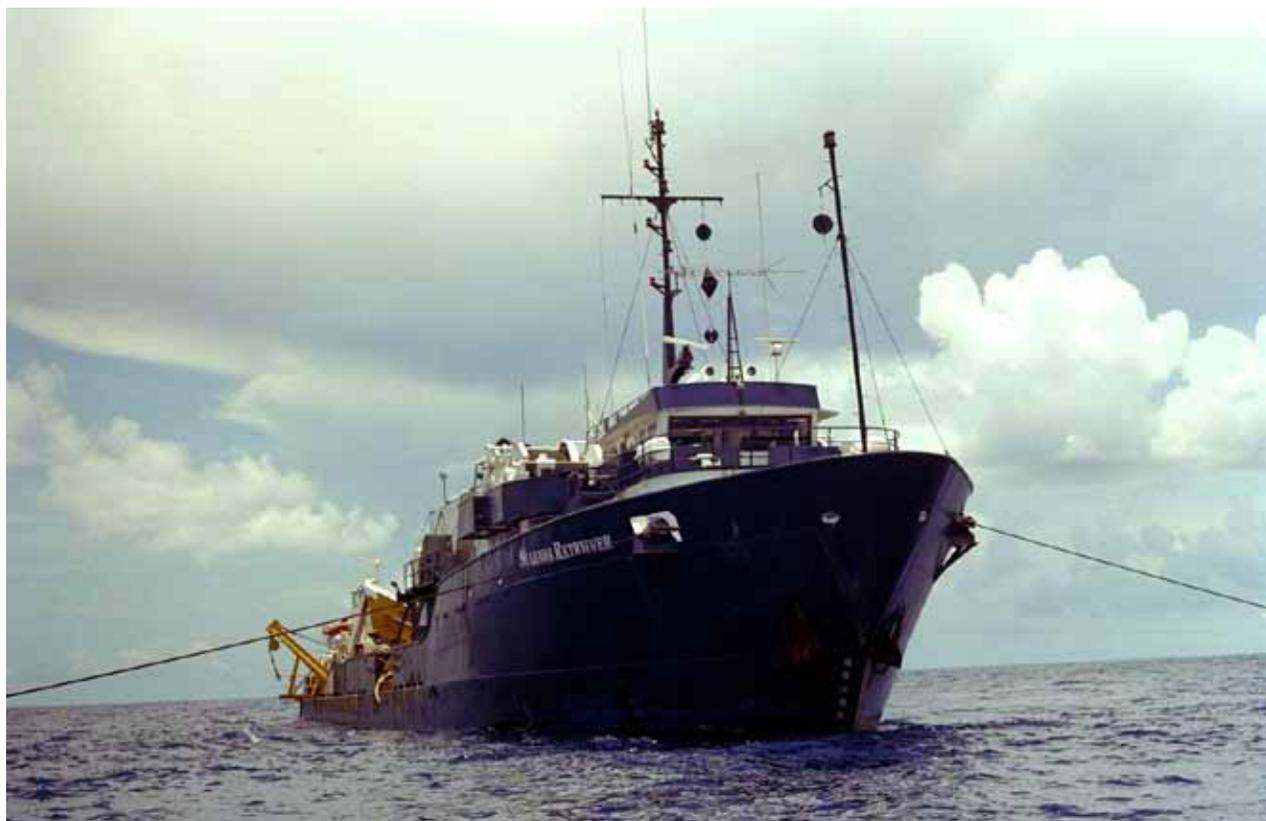
Fig. 2. The Seahawk Retriever in port. Photo: John Astley.

Fig. 3. The Seahawk Retriever anchored over the Tortugas shipwreck site on a four-point mooring. Photo: John Astley.

In order to commence excavations with suitable technology, a second vessel, the 64m-long *Seahawk Retriever*, was dispatched to the site in May 1990 (Figs. 2-3). Originally called the *Tera Tide*, this vessel was built in 1974 by Burton Shipyard, Texas, as a twin screw supply vessel for transporting and pump drilling mud in the oilfields of the Gulf of Mexico. Of welded steel construction, and with a flush deck aft and raised deck forward, a model bow, square stern and steel deckhouse, the ship was retro fitted for the Tortugas shipwreck excavation with low pressure Bratvaag winches for managing a four point mooring system (Fig. 3), cranes for hoisting equipment and artifacts, a billeting module for housing additional personnel, a complete suite of communications and security technology and a control module for the ROV. The *Seahawk Retriever* was equipped with living facilities for a 30-person crew (Appendix 2).

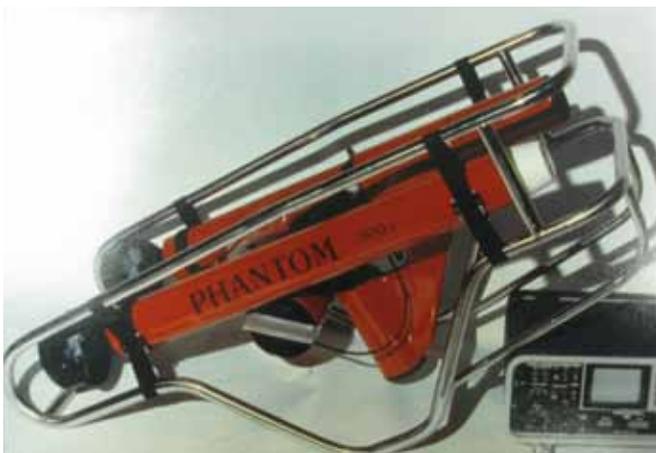
Fig. 4. A DOE Phantom 300 ROV used for visual reconnaissance from the RV Seahawk.

a mid range ROV. Finally, a Phantom 300, with a depth rating of 90m and color video, functioned in shallow water (Fig. 4). The RV *Seahawk* was capable of holding station under its own power without anchoring by ‘liveboating’ the vessel during ROV operations.

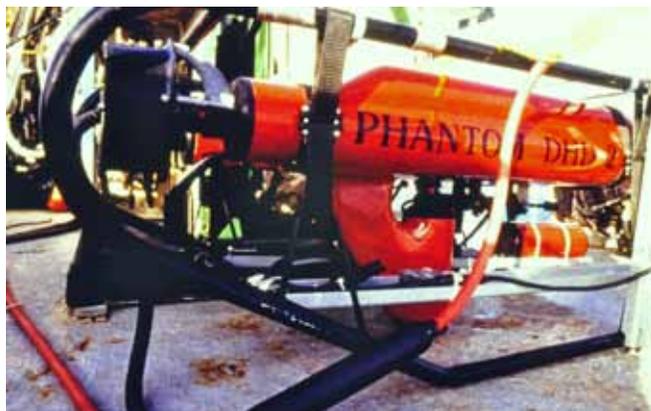
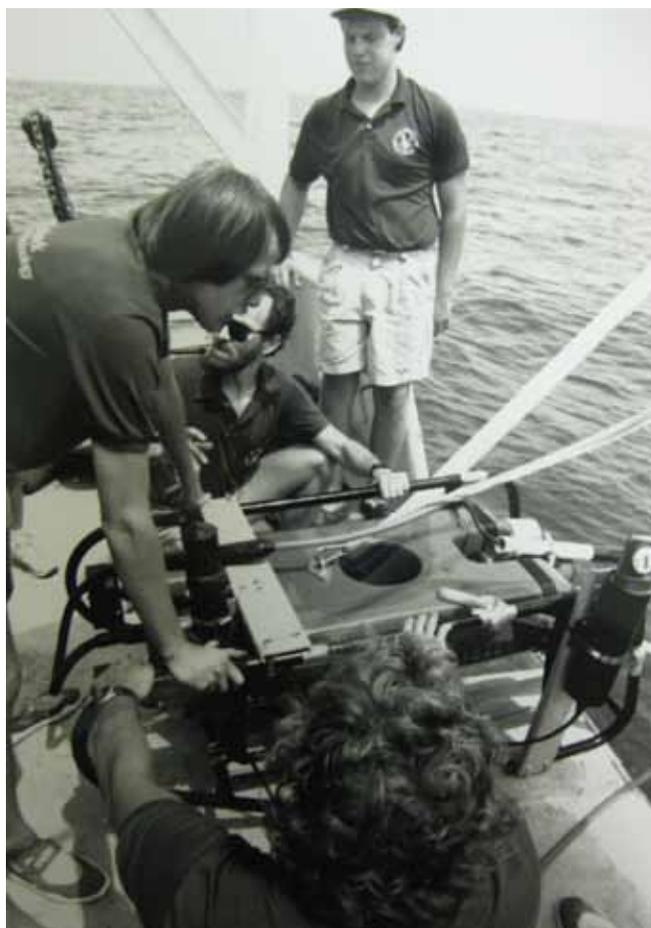
Figs. 5-6. The initial visual wreck survey was accomplished using a Phantom DHD2 ROV (top) being launched by Scott Stemm, Dr. James Cooke, David Six and Steve Dabagian.

Initial visual survey of the wreck site was accomplished using the Phantom DHD2 ROV (Figs. 5-6), which was equipped with a Mesotech 971 sector scanning sonar and was utilized to define the location and perimeter of the site. The ROV was linked to *Seahawk* via 610m of shielded 42 separate conductor umbilical cable (no single wire multiplex control system was available in 1990-91) and was fitted with two 250-watt halogen lights and two Panasonic CCD low light video color cameras to illuminate the site. The Phantom DHD2 had a single function manipulator arm to provide dexterity for the retrieval of artifacts and was equipped with an ORE multi-beacon, which emitted an analog signal received by a Trac Point II tracking system. DHD2, with dimensions of 0.6 x 0.9 x 1.2m,

including its protector bars, weighed approximately 68kg and was propelled by six thrusters. The pilots flew the ROV using a ‘joy stick’ control and observation via a small TV monitor mounted in the control console. A ‘co-pilot’ managed the camera adjustments, recorders and manipulated the retrieval arm.

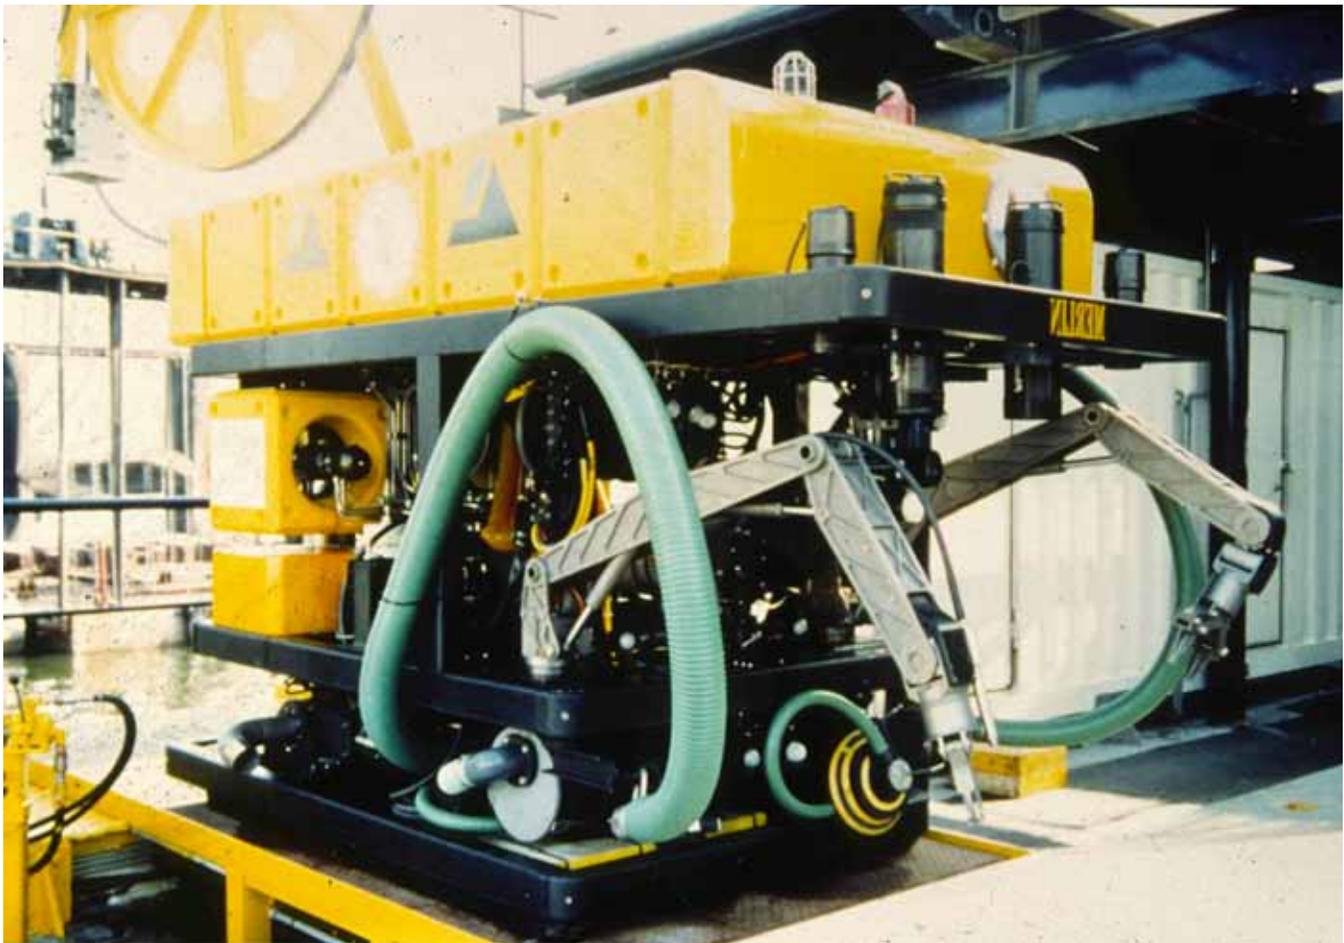
Fig. 7. The 3-ton ROV Merlin built for the Tortugas shipwreck excavation; with its SeRF system hose and nozzle at front right, two manipulator arms and limpet suction device at center. Along the badge bar are two 35mm cameras and two 70mm still cameras.

positioning system and weighed approximately 3 tons out of water (Figs. 7-12). Buoyancy blocks of syntactic foam (to resist the crushing effects of pressure at 400m) made Merlin 272kg positively buoyant. The ROV had six hydraulic-powered positioning thrusters; vertically oriented thrusters allowed it to work above the seafloor without stirring up sand or silt. In other words, Merlin floated and used thrusters to push itself down, which enabled the system to hover safely over the site. Thrusters also held the ROV steady when artifacts were lifted. Either manipulator arm could lift up to 113kg without affecting Merlin's position in the water. One of the manipulators used a master/slave system controlled by a master replica of the manipulator at the surface desk; the jaw pressure could be dialed up to 500lbs or reduced to a few ounces. Positioning was determined and recorded by a system of long baseline transponders installed on the site, which communicated with transponders on Merlin and the ship.

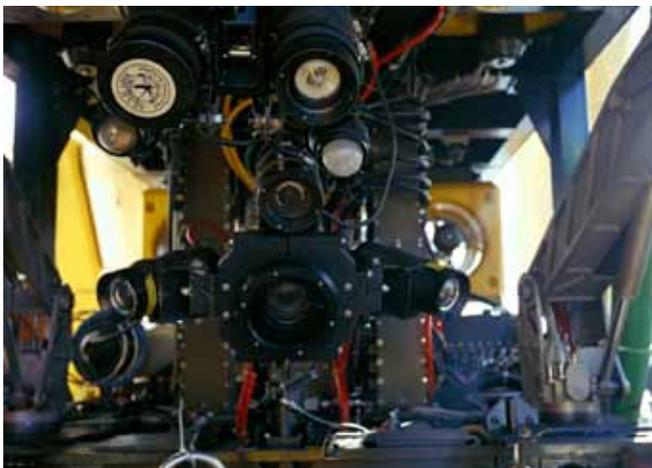
Fig. 8. Cameras and strobe lights at the front of the ROV Merlin. Photo: John Astley.

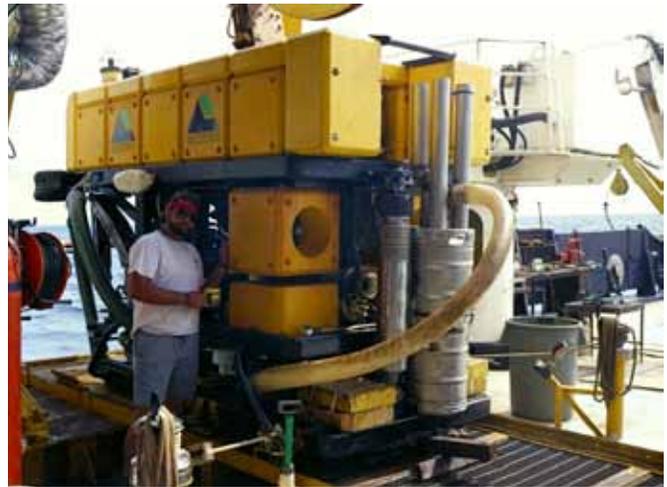
Fig. 9. The SeRF (Sediment Removal and Filtration System) tool for sieving small finds custom-designed for the Tortugas shipwreck excavation and installed onto the rear of the ROV Merlin. Photo: John Astley.

The dredge receiver into which spoil was filtered was constructed from two 18 US gallon stainless steel pressure beer barrels built onto the rear of the ROV Merlin (Figs. 9-11). Its content size was suitable for dredging a cubic meter of clay (about one ton). When full the receiver typically held about 25% clay and 25% hard objects (stones, shell and small finds including pearls, seeds, coins, beads, glass, and human and animal teeth: Figs. 31-32). Simultaneously, nearly a ton of clay had exited via the three exhaust stacks in the form of fine debris that drifted away from site and created no visibility issues.

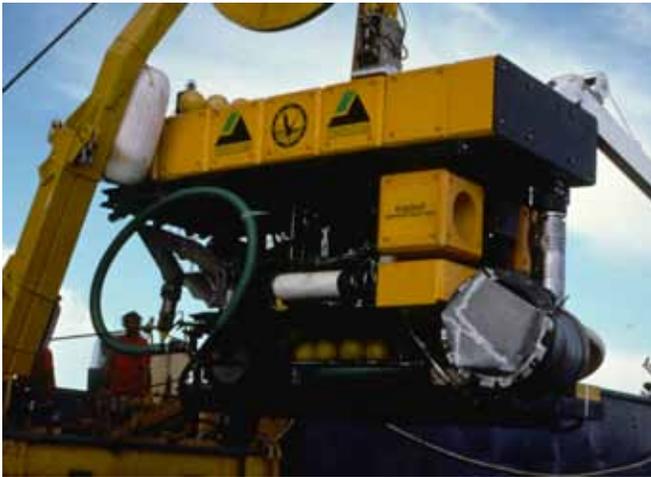
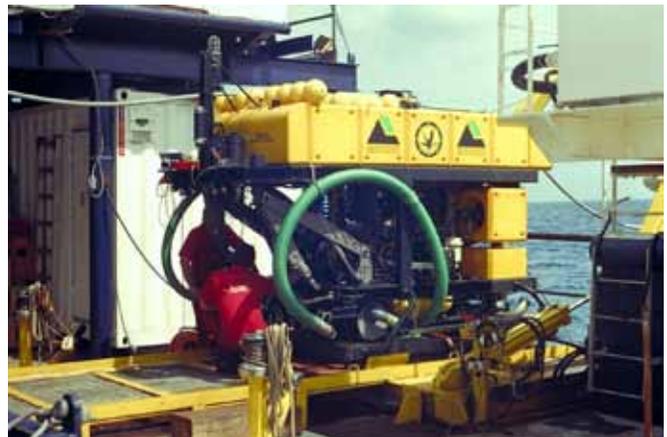
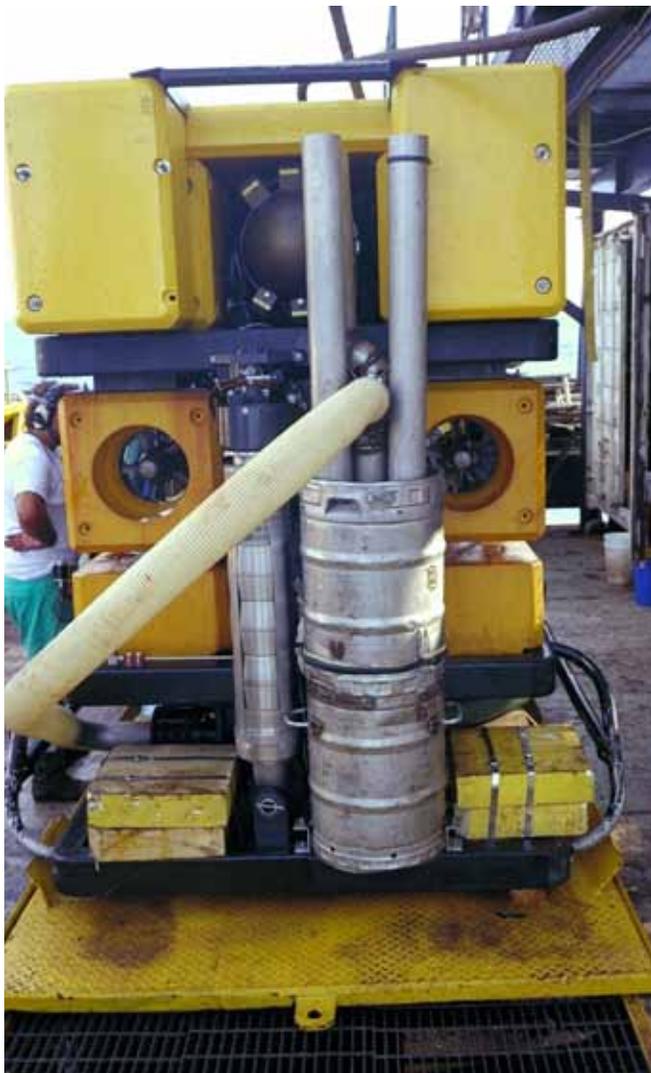
Fig. 12. The ROV Merlin docked onto the deck of the Seahawk Retriever. Photo: John Astley.

Figs. 10-11. The custom-designed receiver and venturi pump from the SeRF (Sediment Removal and Filtration System) unit installed onto the rear of the ROV Merlin (with an early prototype at top). Photo (Fig. 11): John Astley.

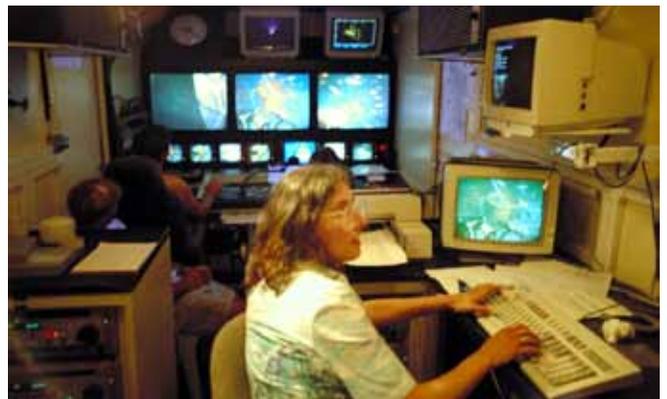
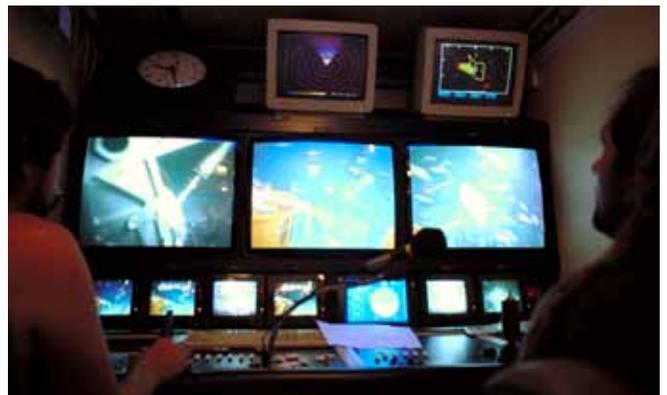
Fig. 13. The archaeological recording and datalogger room on the Seahawk Retriever from where excavations were observed and documented. Photo: John Astley.

Fig. 14. Monitoring archaeological operations on the Tortugas shipwreck from the Seahawk Retriever. The top screens displayed sonar and navigation. The three middle colour screens revealed a very wide view of the site under investigation. The lower row of screens depicted compass, vehicle instrumentation and stern camera data, plus other cameras monitoring the ROV parts. In the foreground the datalogger runs four SVHS recorders and the logging system. Photo: John Astley.

A crew of three technicians operated the ROV from the control room onboard the *Seahawk Retriever* (Figs. 13-14) under the supervision of the project archaeologist. Video was relayed to the control room via fiber optic cable, where three 30in video screens provided a 180-degree view of the underwater excavation site. One Photosea 35mm camera and two 70mm cameras (oriented so that stereoscopic still photos of artifacts *in situ* were possible) provided still photography. Merlin's Schilling manipulators were made of titanium and included a five-function and a seven-function unit. Pilots watched events on the seafloor live in real time on monitors and commanded the manipulator arms using joysticks at the control console aboard the *Retriever*.

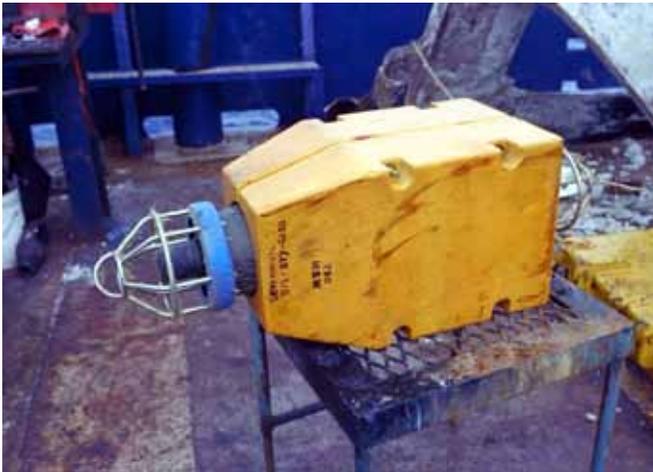
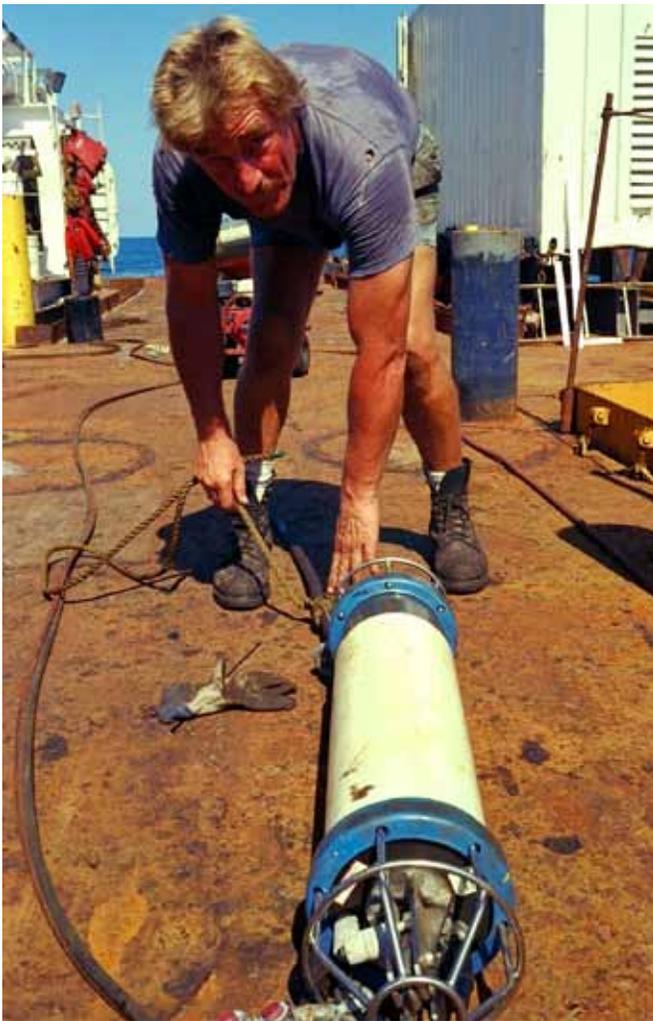
Fig. 15. A Sonardyne transponder, with the transducer at left and the hook release at right, all encased in a buoyancy jacket to facilitate recovery. Photo: John Astley.

Fig. 16. Alan Crampton rigging a Sonardyne transponder for deployment. Photo: John Astley.

The Sonardyne long baseline system used for positioning included a set of transponders that were placed in a seabed array and interrogated by the ROV, or the ship, to obtain positional information. Calibrating arrays of this type and gauging the precise distance between transponders on the seabed had always been an inherent problem. Traditionally this had been executed using transponders that ‘ping’ (transmit a single tone but no telemetry) and by steaming the ship around the site and interrogating the transponders to compare positions with surface radio navigation systems, thereby obtaining a calibration. This method produced a reasonable result in shallow water, where the temperature and salinity of the local water column was known and in an area where surface navigation facilities were good (bearing in mind that in 1989 GPS was not yet available).

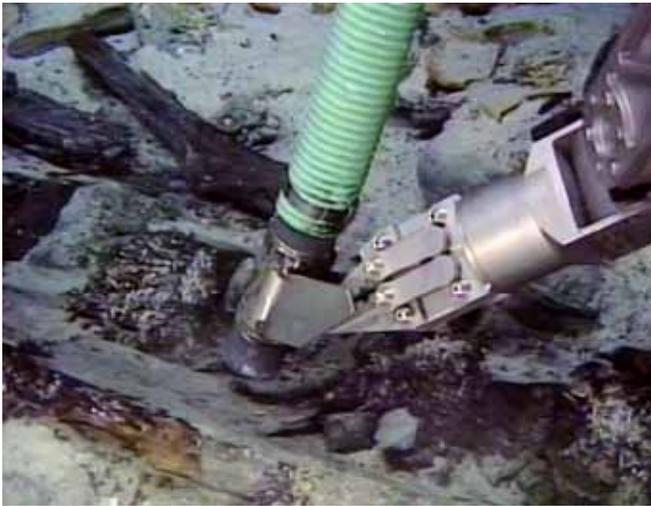
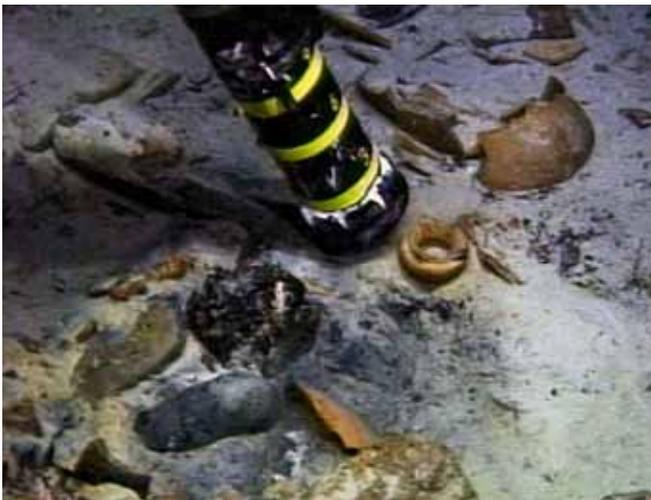
Figs. 17-18. Removing overburden on the Tortugas shipwreck using the SeRF system.

The sediment removal and filtration (SeRF) system used on the Tortugas excavation was a 25hp hydraulically-driven three-stage water pump (Figs. 17-18). This venturi pulled water and unobserved small finds through the main system (Fig. 36). No artifacts passed through any mechanical portion of the pump, so there was no damage to cultural remains that might have traversed the system. In addition to working sensitively around archaeological remains, this system could extract solid clay at full power. It could also be reversed to back flush the system or blow away silt and sand.

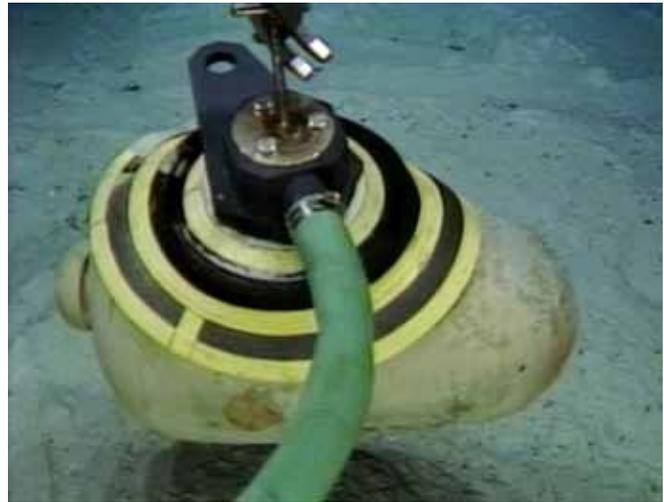
Fig. 19. An early limpet suction device developed for the Tortugas project being used to recover an olive jar.

Perhaps the most resourceful modification custom-made by the Tortugas team was the attachment to the ROV of a small, 5cm-diameter bellows type suction cup (Figs. 19-21, 36-37). The suction delivered to this device

was controllable by the operator. The cup could pick up the most delicate porcelain and olive jars without causing damage, yet could still remove large angular ballast stones. The invention and adoption of this limpet system on the Tortugas shipwreck went through several phases of on-site development and was the first application of this tool on a deep-sea archaeological excavation. The system is now a standard tool utilized by Odyssey Marine Exploration and other archaeological operatives.

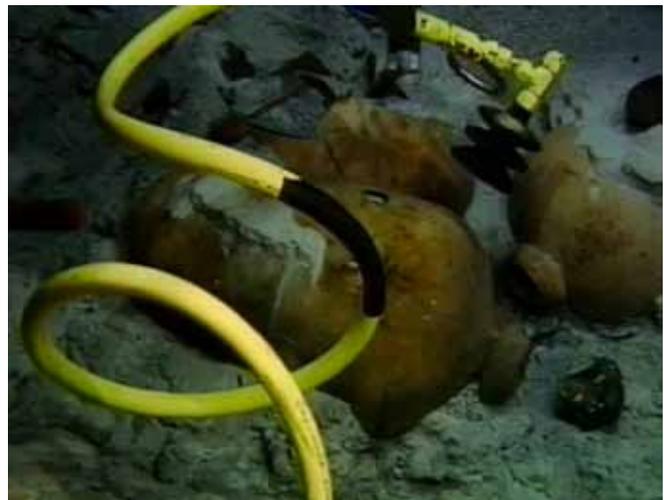
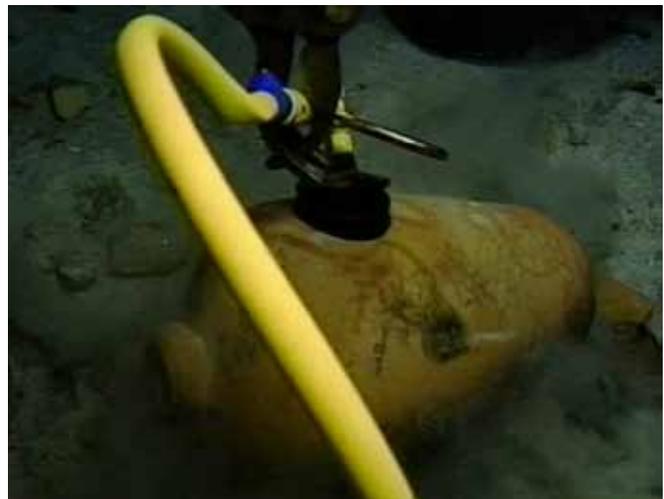
Figs. 20-21. An evolved small limpet suction bellows device used to recover artifacts from the Tortugas shipwreck inspired from paper printing industry technology.

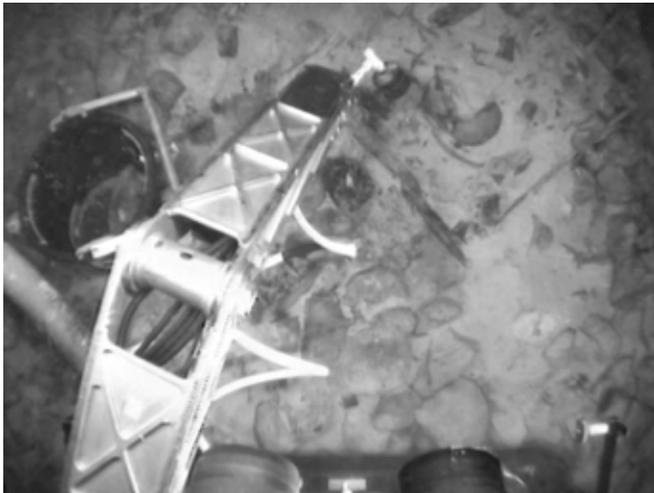
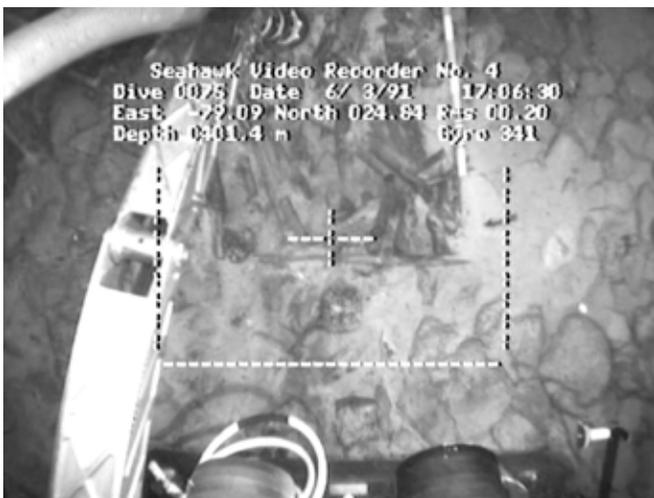
Fig. 22. Observation of Merlin excavating, using the ROV's vertical black and white still camera.

Fig. 23. Observation of Merlin excavating using the ROV's vertical black and white still camera, with its electronic grid position and geospatial data superimposed over the image. Similar data could be observed on all live and recorded video data.

A Navigation Camera was situated on the front of the ROV that looked down vertically to navigate movements safely. A video overlay system generated a white cross-site in the center of this picture (Fig. 23). The ROVNAV transducer carried by the ROV was fitted just above this camera so its crosshairs were centered directly below the transducer, which provided the known location on the site. This camera served as the vehicle's datum.

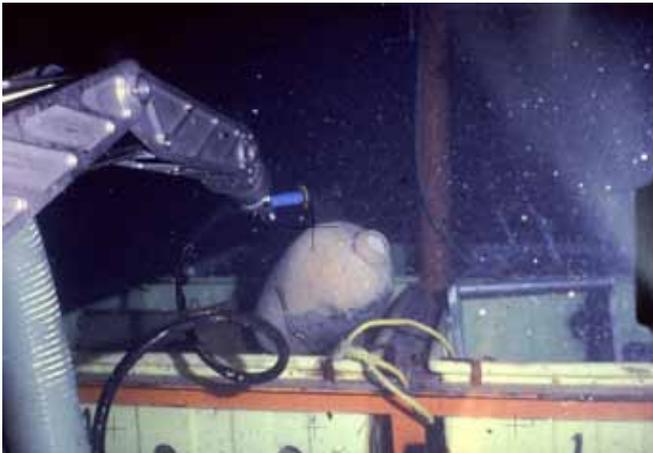
Fig. 24. An olive jar being secured into a 4Plex unit by the ROV Merlin using its limpet suction device.

tate carrying by the ROV manipulator arms. The baskets were placed in sectioned off partitions in the large steel basket designed for retrieving artifacts from the sea bottom, nicknamed the 4Plex, which had a lifting capability of 3 tons (Fig. 24).

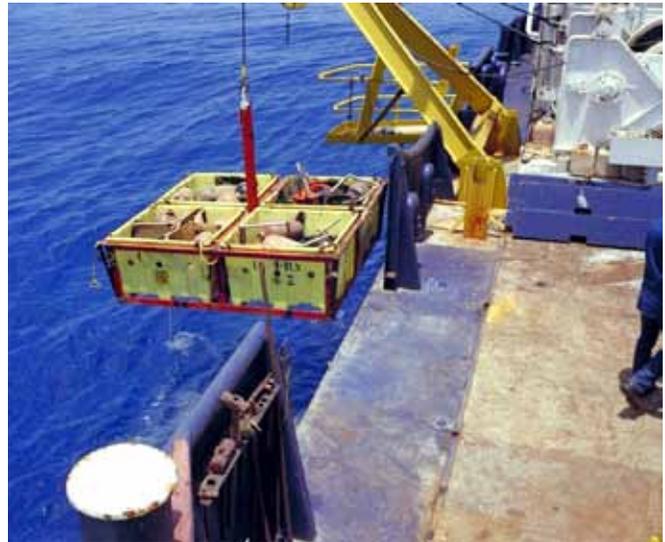
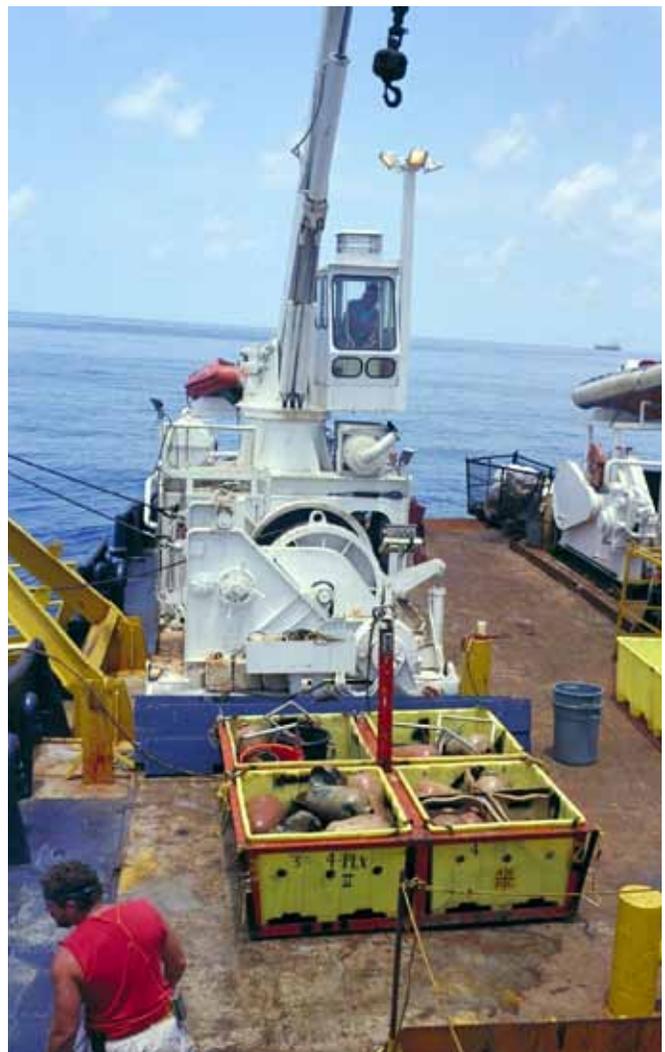
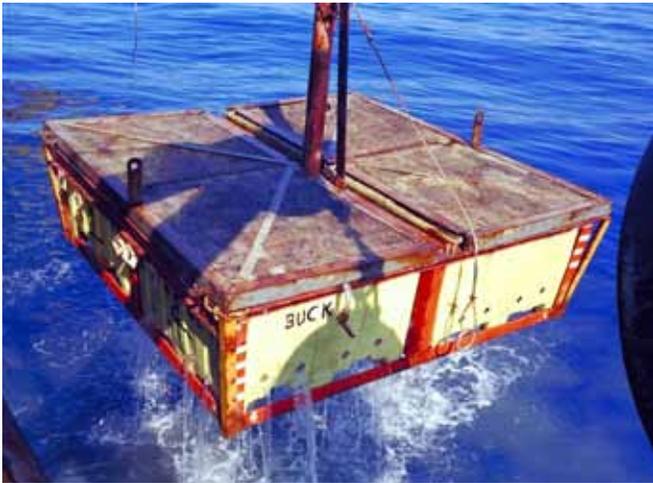
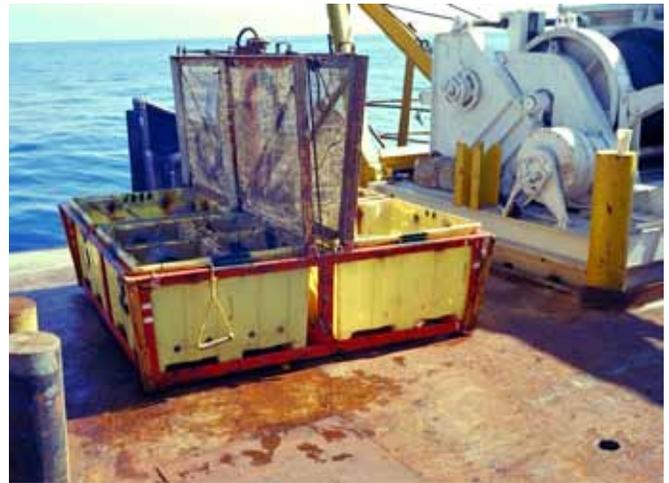
Figs. 25-26. Artifacts secured in a 4Plex unit being winched onto the deck of the Seahawk Retriever. Photos: John Astley.

Figs. 27-28. Numbered 4Plex units were recovered with a closed lid protecting the artifacts. Photos: John Astley.

When the 4Plex was ready for recovery, a wire was lowered from the research vessel's recovery winch. Near the hook on this wire was a transponder that enabled the ship to reposition itself using its winches to guide the hook to within 50m of the 4Plex. When the hook arrived near the sea bottom the ROV approached it, grasped it with a manipulator and conveyed it to the 4Plex, where it could be hooked on and lifted to the ship (Figs. 25-30).

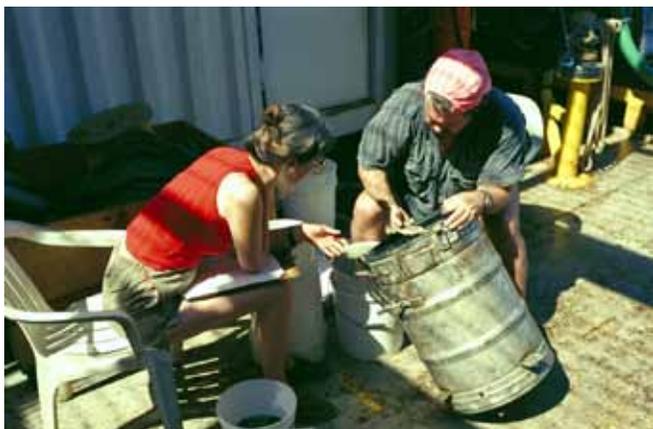
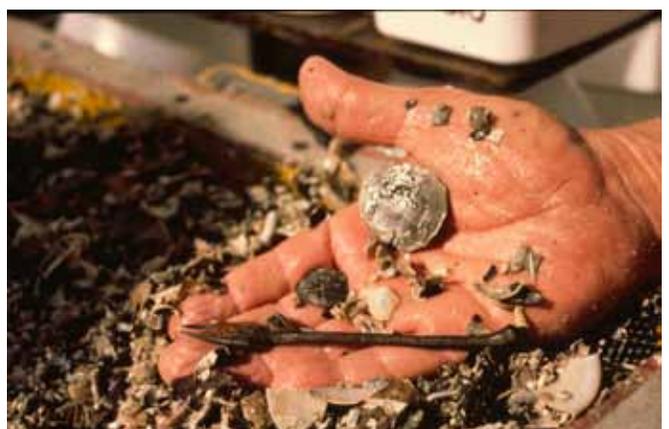
Figs. 31-32. Archaeologist David Moore examines sieved spoil recovered from within the ROV Merlin's SeRF (Sediment Removal and Filtration System) unit. Photo (Fig. 31): John Astley.

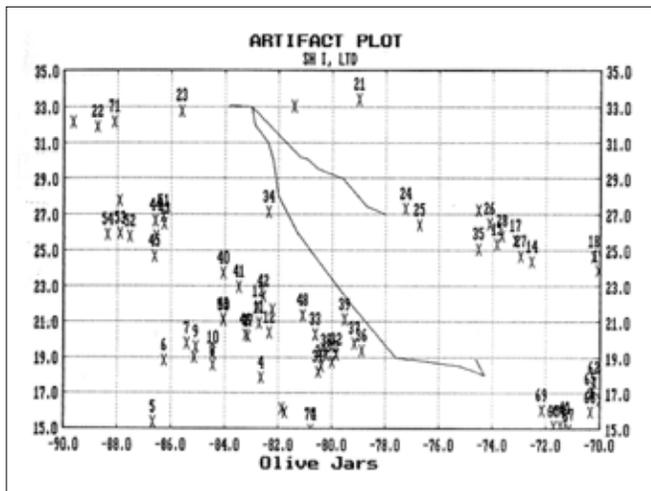
Fig. 34. An example of an original computer generated artifact plot from the Tortugas shipwreck excavation, in this case showing the positions of olive jars.

The electronic database, stored on computer disc, could be accessed through a variety of methods. For example, a category of artifacts (ie. olive jars) could be imposed on an outline of the site so that the distribution could be studied. Any combination of categories could be plotted together showing their distribution over the site and contextual relationships. The computer could also be commanded to generate a plot (either on screen or paper) showing the distribution of the gold bars, glazed ceramic bowls or astrolabes, for example (Figs. 34-35). These plots proved invaluable in determining relationships between artifacts and site contexts during the course of the excavation – and then to recreate the site through post-processing after the project was completed.

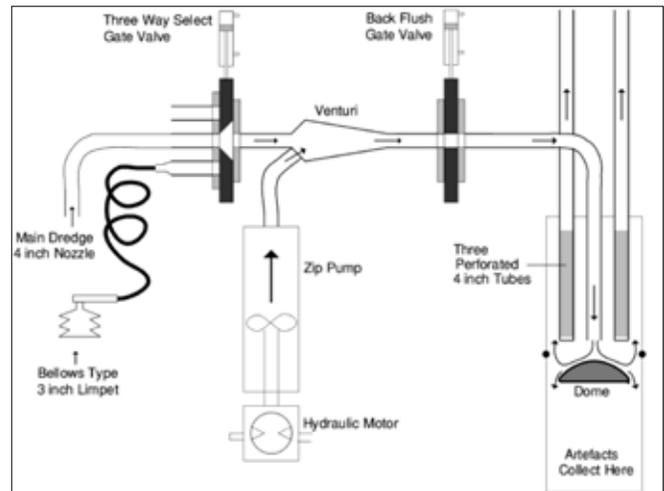
Fig. 36. A schematic diagram of the construction and operation of the venturi SeRF system developed for ROV Merlin for the Tortugas shipwreck excavation. Drawing: John Astley.

Many methods were tried and tested to filter sediment that might contain small finds unnoticed during excavation. Any form of screen or filter inserted into the venturi soon blocked up and curtailed the dive. A successful method was subsequently evolved based on the principle of a fuel filter using a container on which liquid is dropped from the top onto a domed plate. Solid objects fall to the bottom of the vessel beneath the domed plate. Excess water and fine silt was then discharged at the top, where it was ejected through a 2m-high stack.

A ram-operated, three-way select gate valve was utilized to select between usage of the main dredge nozzle and the suction limpet used for lifting artifacts. The venturi used was a 'Banjo' type, which ejected water through a ring. The aperture in the center, 9.0cm diameter, passed the

induced flow through the dredge nozzle. The main water pump relied on was a three-stage turbine, which required about 80 liter/min at 200 bar. The dredge nozzle and lifting suction limpet were stowed on hooks positioned near the Schilling Titan manipulator. The SeRF system nozzle measured 10.2cm in diameter and was attached by a flexible tube. The lifting limpet was adapted to a self-coiling airline hose.

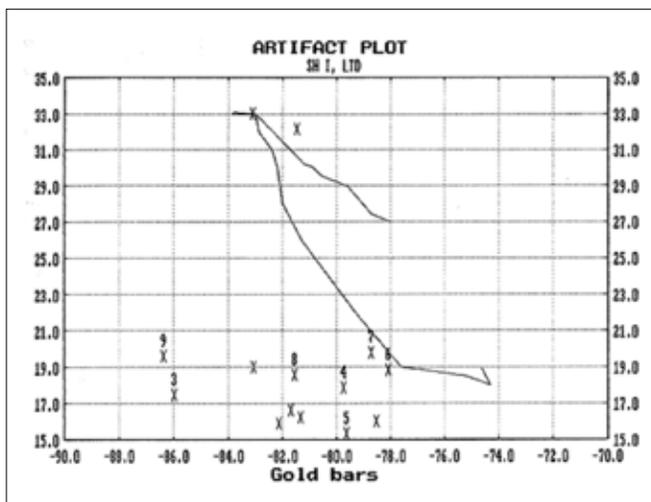
Fig. 35. An example of an original computer generated artifact plot from the Tortugas shipwreck excavation, in this case showing the positions of gold bars.

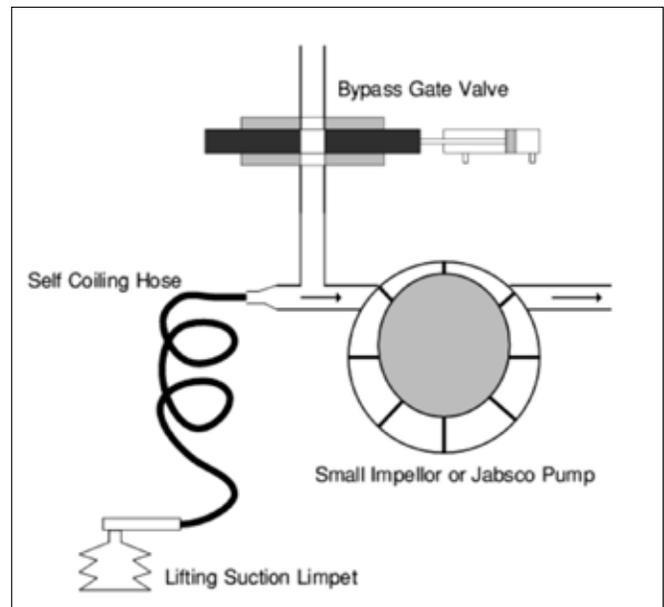
Fig. 37. A schematic plan of the limpet suction device developed for the Tortugas shipwreck excavation. Drawing: John Astley.
